Thermoelectric Power Plant In Chile Protects Secondary Containment Areas With ENECRETE & CHEMCLAD

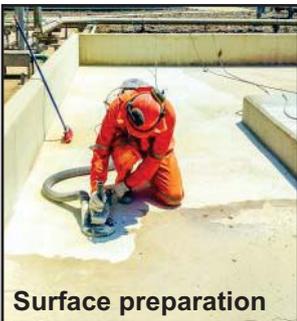
Surface preparation

The ENECON Chile team removed all contaminated concrete as well as old, failed coatings. Broken and cracked concrete areas were repaired and rebuilt with *ENECRETE DuraQuartz* and *ENECRETE DuraFill*.

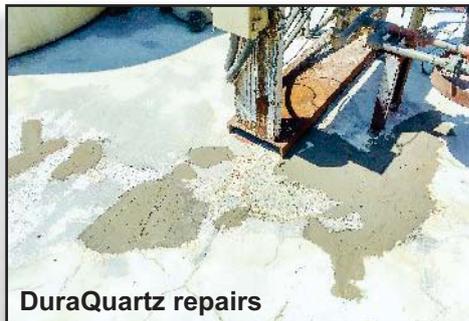
DuraQuartz repairs

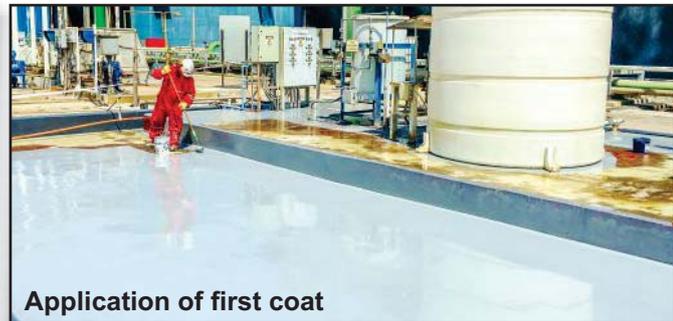
Application of first coat

The entire surface of the secondary containment areas were then coated with two coats of *CHEMCLAD XC* and *CHEMCLAD SC* (depending on the chemical exposure), providing superior chemical attack protection from these extreme conditions for years to come.

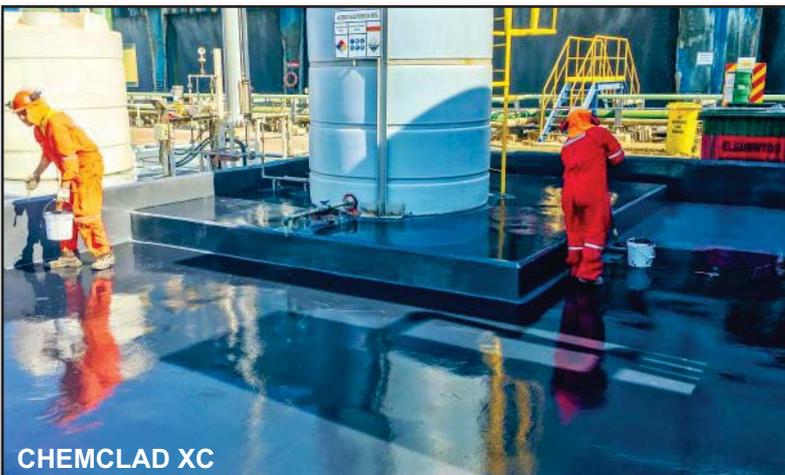
CHEMCLAD XC

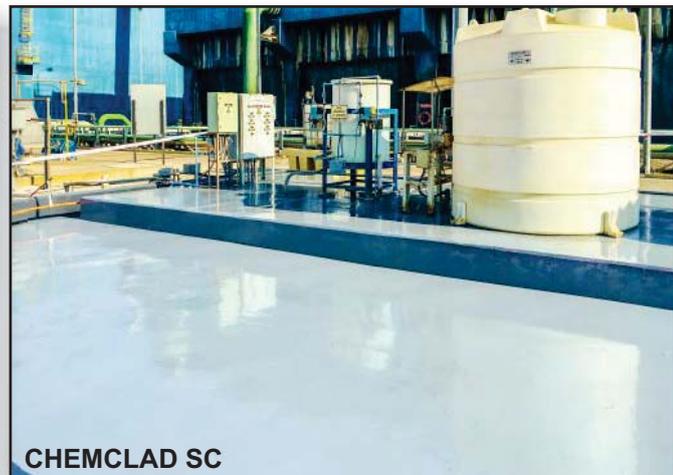
CHEMCLAD SC
