The engineers were thrilled with the outcome of this application in addition to the job being completed in one week, on-time and under budget. CHEMCLAD SC Protects Concrete Containment Area From Exposure To Sodium Hydroxide

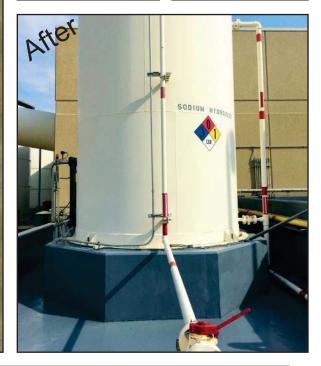
Wastewater treatment facilities use caustic chemicals in their processes daily. At this Texas facility, the fiberglass lining of a sodium hydroxide tank containment area needed to be replaced.

Several areas of concrete also needed to be repaired because of direct contact with the chemical.

The fiberglass liner was completely removed and the surface of the concrete was ground down to a 'roughened' profile. It was then cleaned of any loose debris. ENECRETE DuraQuartz was used to patch all the damaged concrete areas. The entire area was then primed with CHEMCLAD P4C.

Because of its outstanding corrosion and chemical resistant properties, two coats of *CHEMCLAD SC* were applied over the entire interior surface of the containment area.
