Seattle Area Pump Station Repairs & Protects Containment Area With DuraQuartz, SuperBond & CHEMCLAD

A Seattle area pump station treats water on site with 12% sodium hypochlorite. This is a high concentration to keep the system clear of bacteria and other microorganisms throughout the long pumping distances.

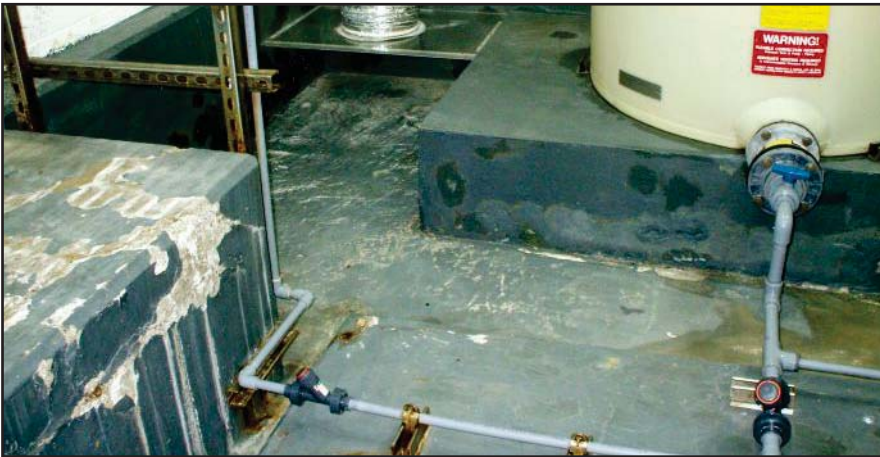
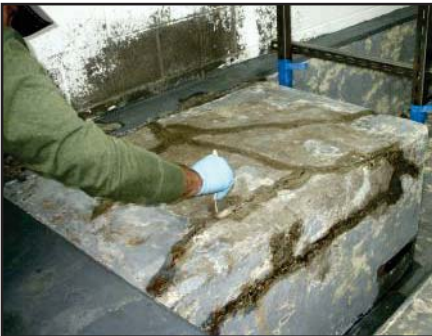
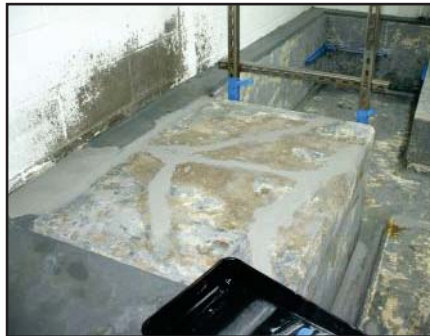
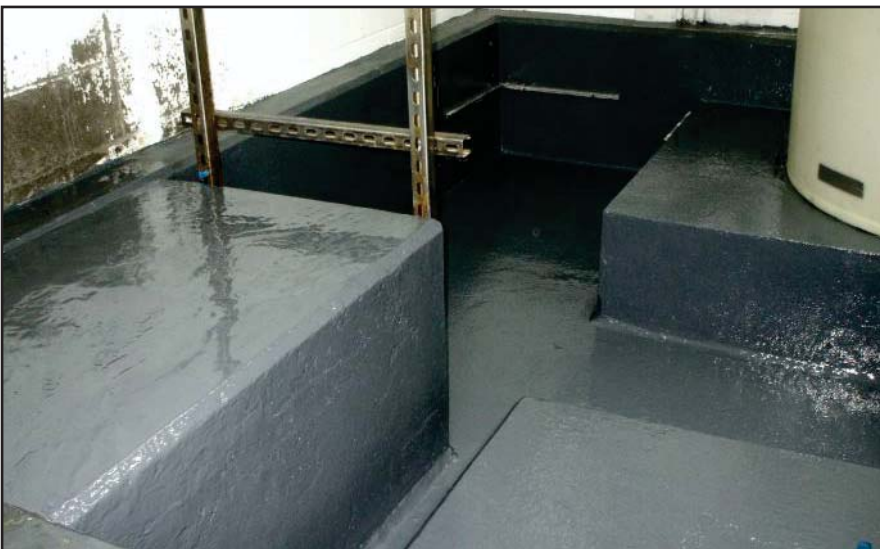
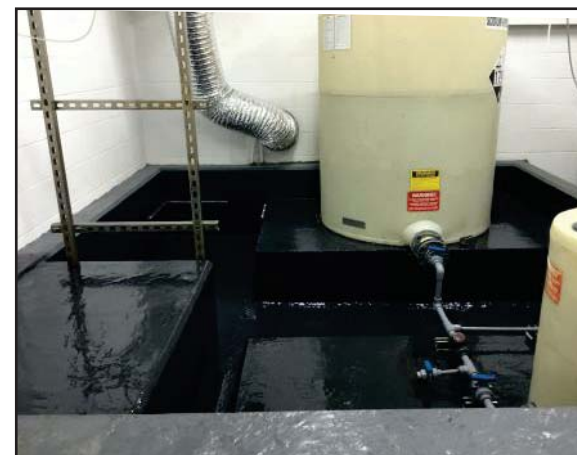
The previously applied coating in the containment area was over 5 years old. There was a tank valve failure at some point within the last several years and the integrity of the coating was breached. There were also multiple failures around the perimeter of the containment area and equipment pedestals.

To prepare the surface they had to grind the existing coating down to bare concrete in all of the failed areas, and heavily scuff the surfaces for profile in the areas where the coating was still bonded to the concrete. The surfaces were then chemically cleaned.

Repairs to all the cracked and damaged areas of the concrete were made with *ENECRETE DuraQuartz*. Additionally, all corners between the walls and floor were filled and radiused with *DuraQuartz* to eliminate the seams and all corners. This was done in an effort to make the containment area "bathtub-like" around the sides.

Finally, all surfaces were coated with *ENECLAD SuperBond* followed by two coats of *CHEMCLAD XC*. This application gave the containment area a seamless, monolithic coating for ultimate protection.
