## Spanish Nuclear Plant Repairs and Protects Secondary Containment Areas with DuraQuartz and CHEMCLAD

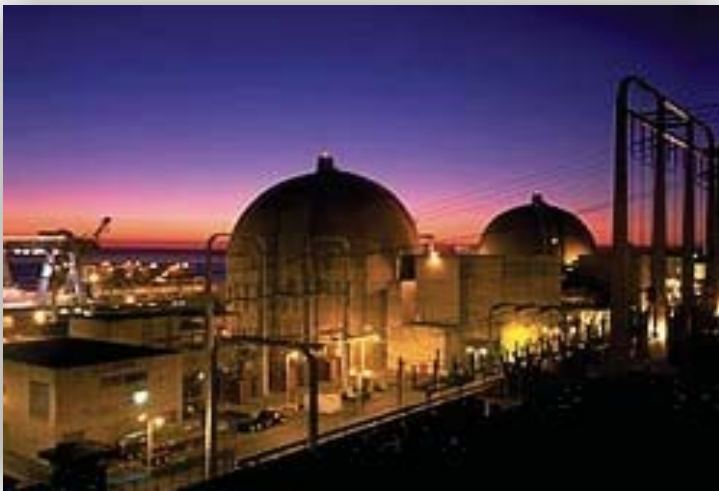
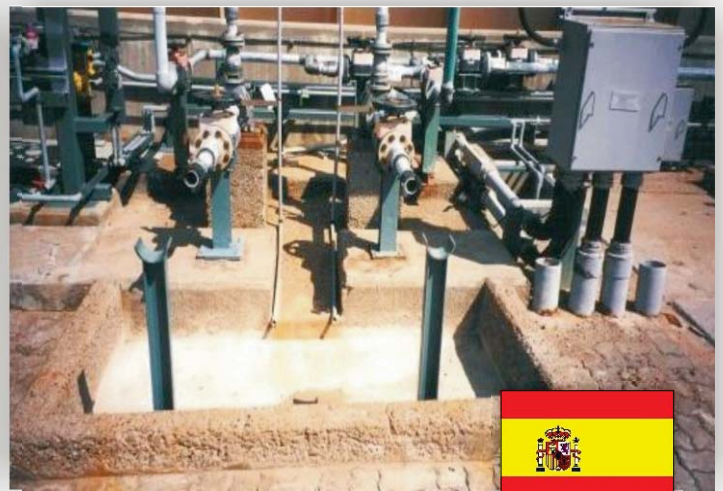
These secondary containment areas and pump supports at a Spanish nuclear power station had been attacked by strong acids

and alkalis for many years, causing severe deterioration and crumbling of the concrete.

It was recommended that the damaged concrete surfaces first be repaired and rebuilt with **ENECRETE DuraQuartz**. This would be followed by a two-coat application of **CHEMCLAD SC** (gray+tan) to provide long-term protection to the containment areas.

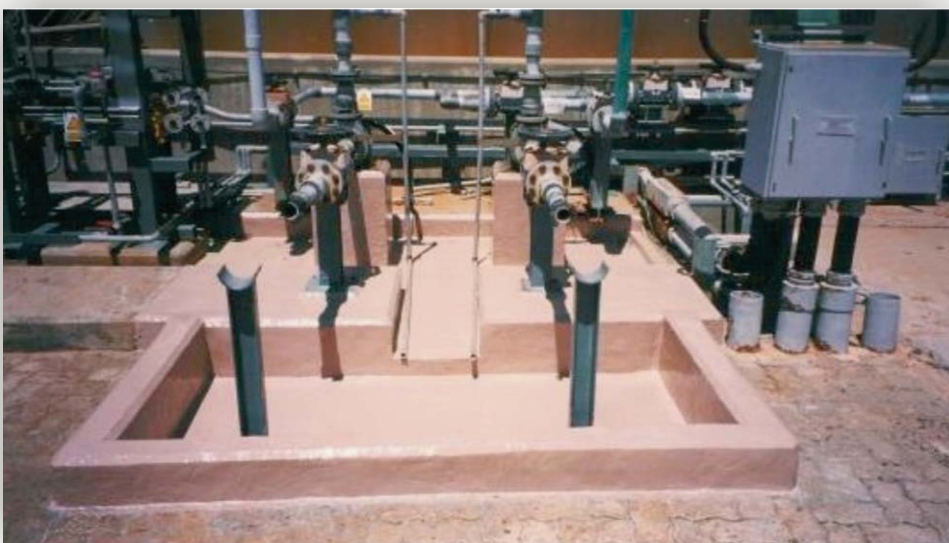
**NOTE: This application has now provided the plant with outstanding performance for over seven years!**
