Northeastern U.S. Power Company Saves Concrete Electrical Tower Base with ENECRETE & ENESEAL

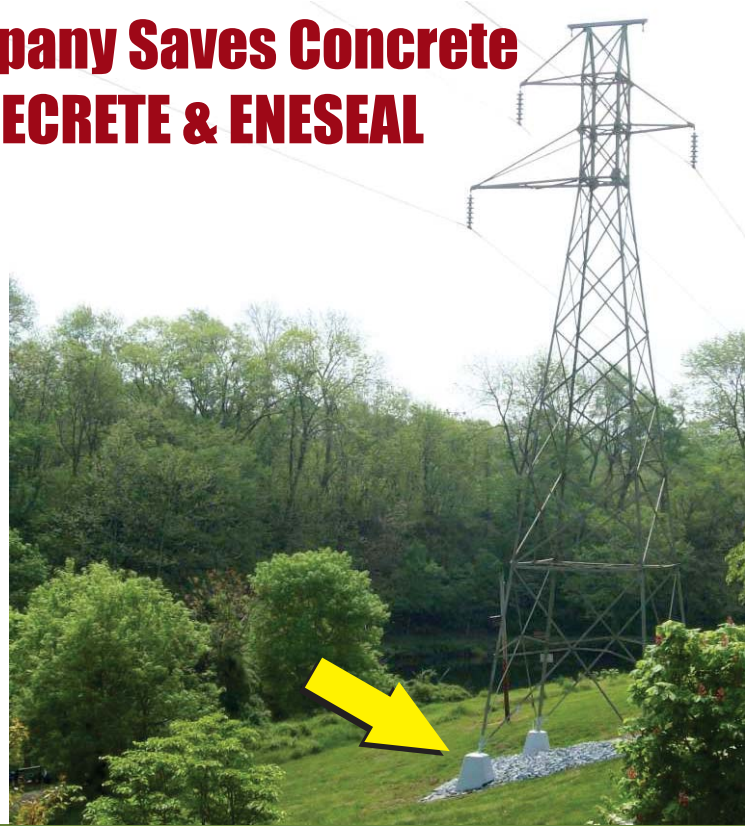
Problem: Electrical tower concrete base was crumbling due to exposure to the elements.

Solution: Loose concrete was manually removed and the base was enclosed with a wood former to re-build its shape. **ENECRETE DuraFill** was mixed with sand and pea gravel and then poured into the former.

After removing the wood former **ENECRETE DuraQuartz** was used to fill in any imperfections to provide a smooth surface to the base.

ENESEAL CR was then applied to prevent corrosion where the steel meets the base as well as to give a clean, uniform look to the structure.
