## ENECRETE & ENESEAL Repair Fire Damaged Concrete Bases of 37 Ton Transformers

**Client:** Northeastern U.S. Municipality

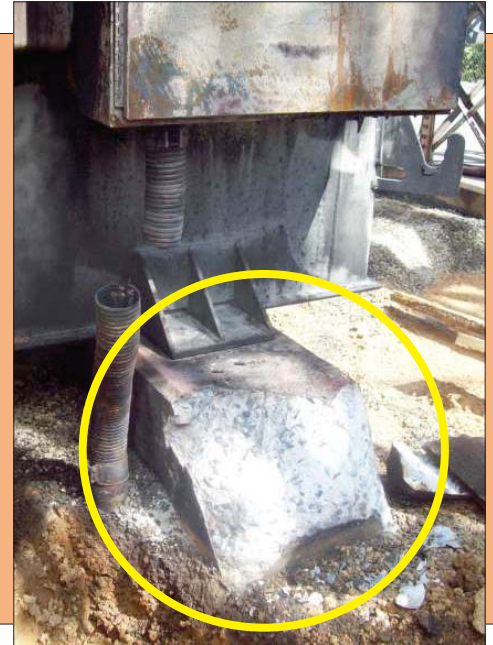
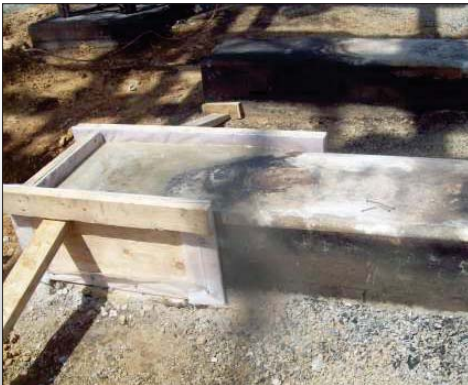
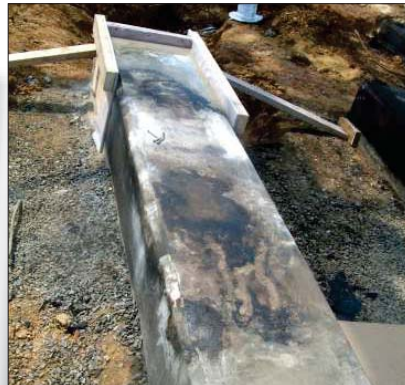
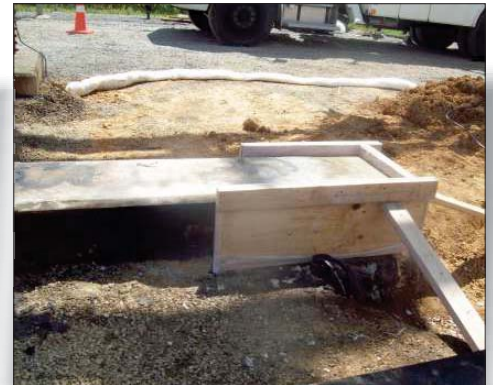
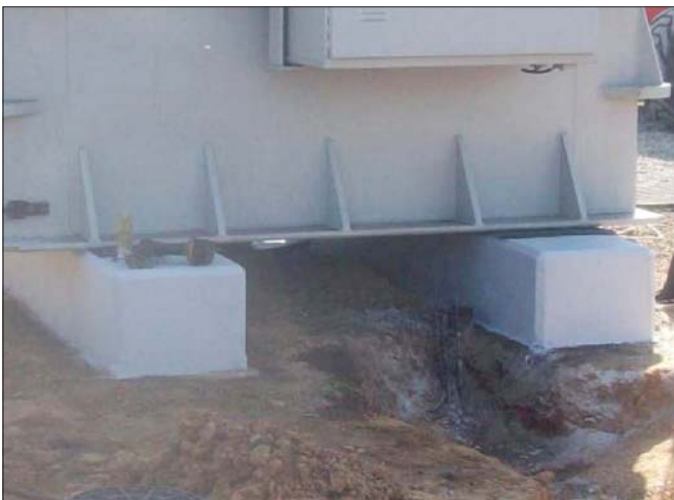
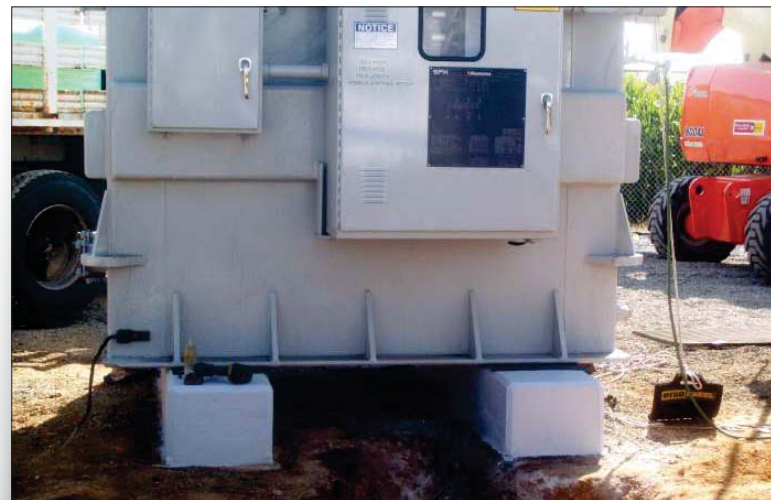
**Problem:** 2 Power transformers were involved in an accidental fire causing them both to have to be removed and eventually replaced. The onsite engineers were concerned about the integrity of the concrete bases the 37 ton transformers were mounted on. Cracks and damage were visible after the transformers were removed.

**Solution:** Loose concrete was removed from the bases as the area was manually prepared. Wood forms were

built around the bases and ENECRETE DuraFill, mixed with a locally sourced aggregate, was used to repair all the damaged areas. ENESEAL CR was then applied to give the bases a uniform look as well as protect them from future environmental exposure.
