Damaged Elevator Floors are an Easy Fix with DuraFill[®]

Martin De Serres, President of ENECON Quebec, provided these pictures of a variety of elevator floors that he has refurbished utilizing ENECRETE[®] DuraFill[®] and locally sourced colored quartz and marble aggregates. He confirms that he has successfully completed dozens of elevator floor repair and reclamation projects during the past few years.

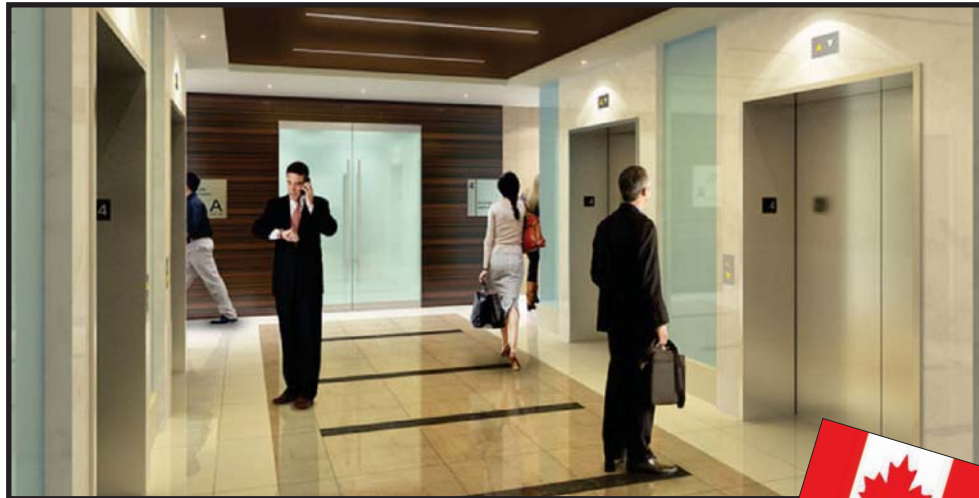
Typically the floors are covered with tiles, linoleum, etc. This is removed down to the plywood sub-floor which is usually about a quarter inch below the elevator door rail. After the sub-floor is cleaned and sanded if necessary, a screed comprising of DuraFill mixed with crushed white marble and colored quartz aggregates is applied by trowel – about 1/8" – 3/16" thick. This is left to cure overnight. The next day DuraFill resins are 'flooded' over the previously applied DuraFill screed to a 'mirror-like' finish. It is now left to cure for 48 hours.

Most of these elevator floors were completed over a weekend so as to provide minimal inconvenience to the building owners/managers. Martin points out that after about 3 weeks the floors will lose their shine unless these are cleaned and waxed regularly. It should be pointed out that cleaning crews like the finish because they find it easy to clean and maintain. It is also resistant to spills, road/sidewalk salts, etc.
