## Russian Fertilizer Plant Solves Floor Problems with ENECLAD® and CHEMCLAD®

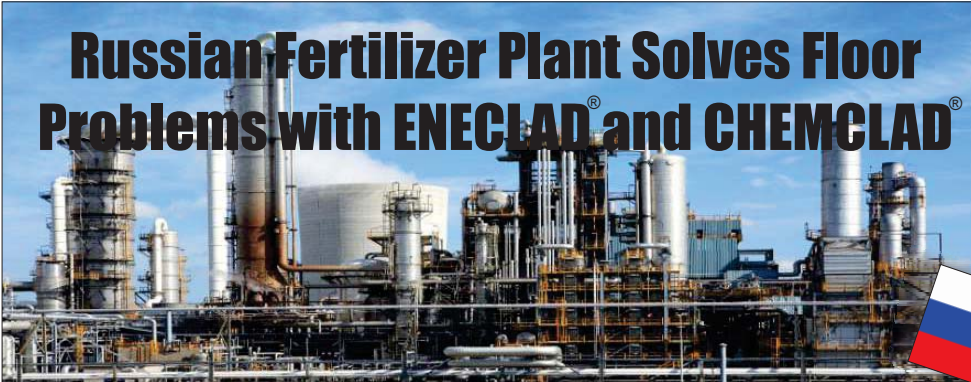
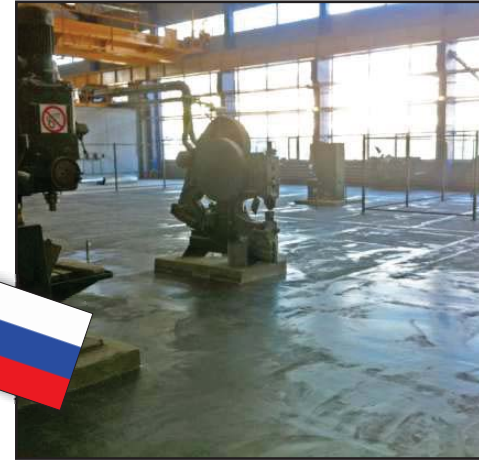
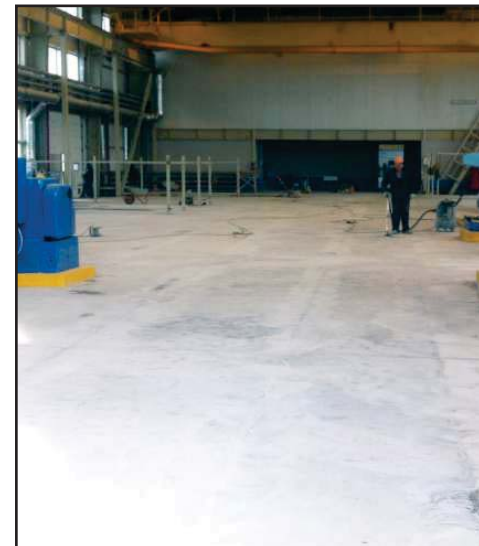
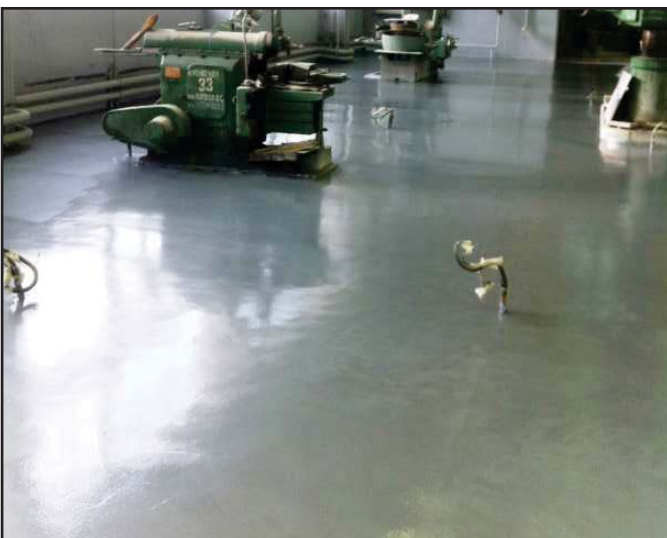
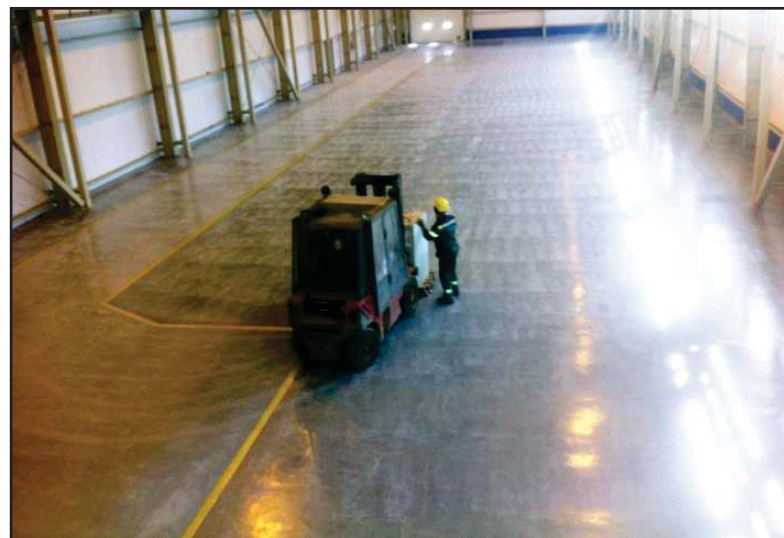
One of the largest chemical companies in Russia – a leader in the production of nitrogen fertilizers – had a number of problem floor issues totaling 90,000 sq. ft.

After sanding/grinding and cleaning the floors, all cracks were repaired with ENECLAD CFS with locally sourced quartz sand added in. Once cured, the cracks were sanded and all dust was removed.

All driveway areas were coated with two coats of CHEMCLAD SC with non-skid aggregates broadcast and back-rolled into the first coat.

The remaining floor areas were treated with

two coats of ENECLAD CFS – the first coat was tinted with a gray pigment and the second coat was left clear.

Yellow markings were done with DuraFill and yellow colored sand. Once cured, excess sand was removed and a top coat of ENECLAD CFS was then applied to seal the striping.
