150 Year Old Cemetery Patio Repaired & Protected With ENECRETE

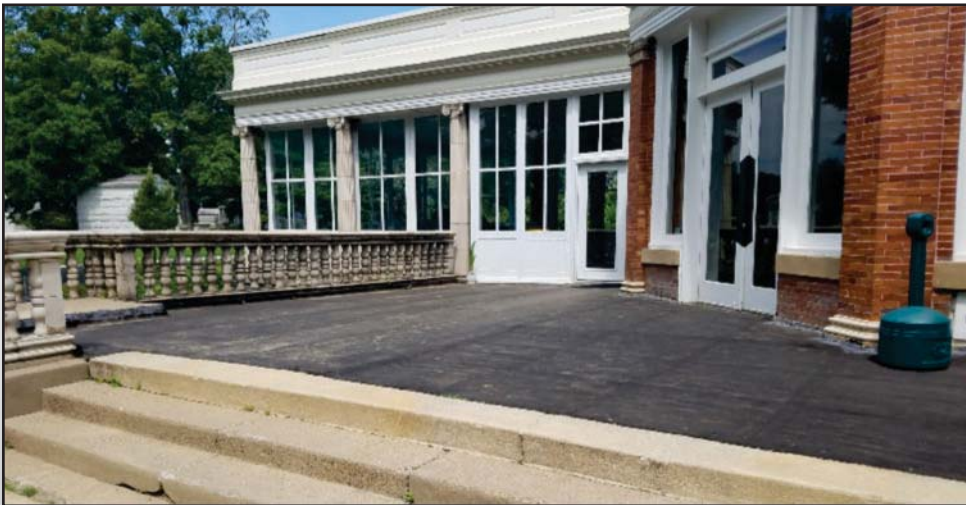
This 150 year old tar covered concrete patio just off the main building at a Pennsylvania cemetery was showing signs of its age. Several areas had uneven surfaces, cracks and gaps which were causing leaks into the storeroom below as well as creating dangerous trip and fall hazards.

Multiple tar and paper layers on top of the concrete patio had to be removed. This proved to be very difficult in some areas requiring the use shingle scrapers, mechanical cutters, grinders and even heavy equipment.

The area was thoroughly cleaned and vacuumed and DuraFill, mixed with locally sourced quartz sand, was troweled to repair the surface of the concrete and create a proper 'grade' in some areas. Two coats of DuraFill with a sand broadcast were then applied as a top coat.
