Starch Factory in Thailand Solves Serious Mineral Scale Problems in Their Cooling Tower With ENEFLOW Power Cells

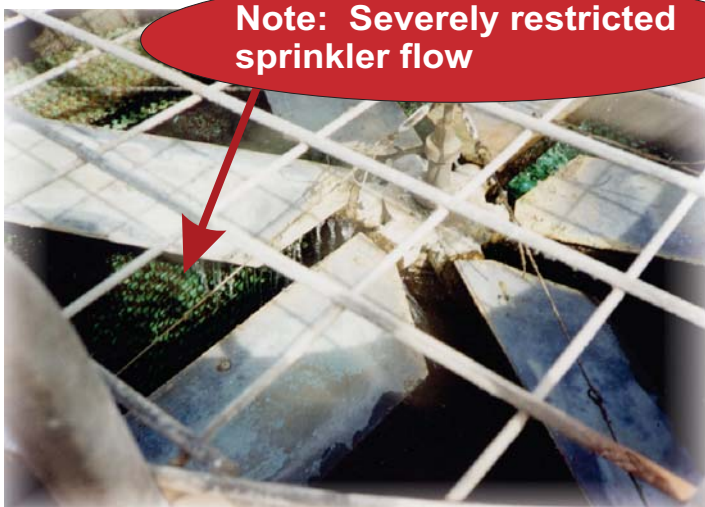
Note: Severely restricted sprinkler flow

This major starch producer in Thailand had an on-going problem with severe calcium carbonate scale build-up in their cooling tower sprinkler pipe.

An ENECON Field Engineer in Thailand suggested an ENEFLOW installation to eliminate, or at least reduce, the scaling problem.

Two pair of ENEFLOW 5000's were installed on the cooling tower's feed pipe and 60 days later the scale had virtually disappeared.

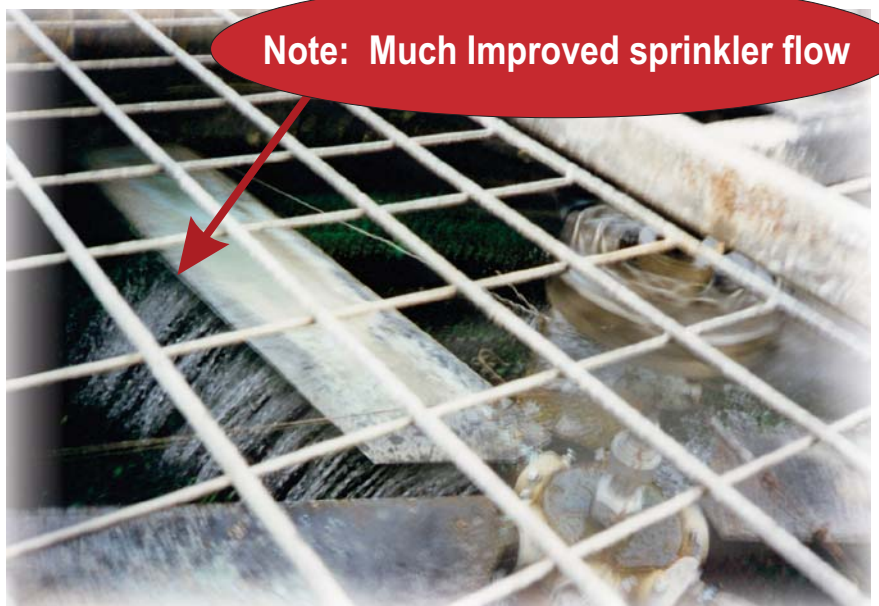
Note: Much Improved sprinkler flow
