ENESEAL Improves Cooling Tower Efficiency While Adding Corrosion Protection at Meat Packing Plant

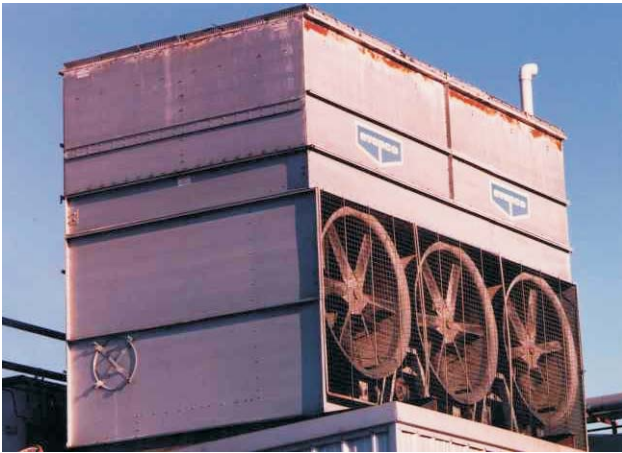
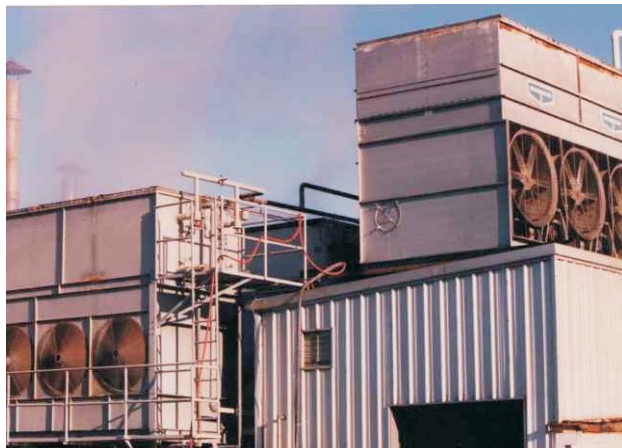
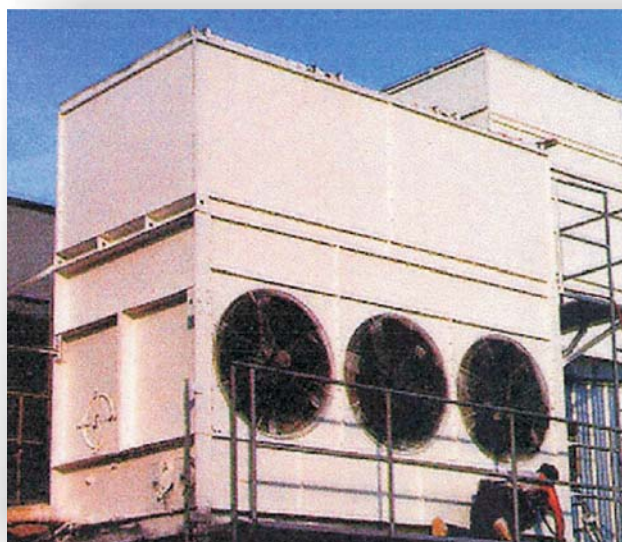
When these two cooling towers - part of the refrigeration system for this meat processing and packing plant in Virginia - needed refurbishing, the facility called in their local ENECON Fluid Flow Systems Specialist for advice.

The original galvanized metal on the units, both measuring 8 feet by 1 foot and standing 15 feet high, had weathered over the years and had become very dull - resulting in efficiency losses to the system. In addition, there was some localized corrosion damage along the top edges due to a fine mist always present in this area.

The units were first blasted, removing all rust down to bare metal. After priming these areas, two coats of the ENESEAL HR were applied using 45:1 Bulldog Airless Spray equipment.

The units were coated during a warm period of the fall with daytime temperatures around 80° (27° C). As the coating of different sections was completed, the plant engineers were amazed at the appreciable temperature difference they could feel with their bare hands between untreated sections and the areas already coated with the ENESEAL HR.
