Nuclear Power Plant in Spain Selects ENESEAL HR to Repair & Protect This Concrete Containment Building Dome

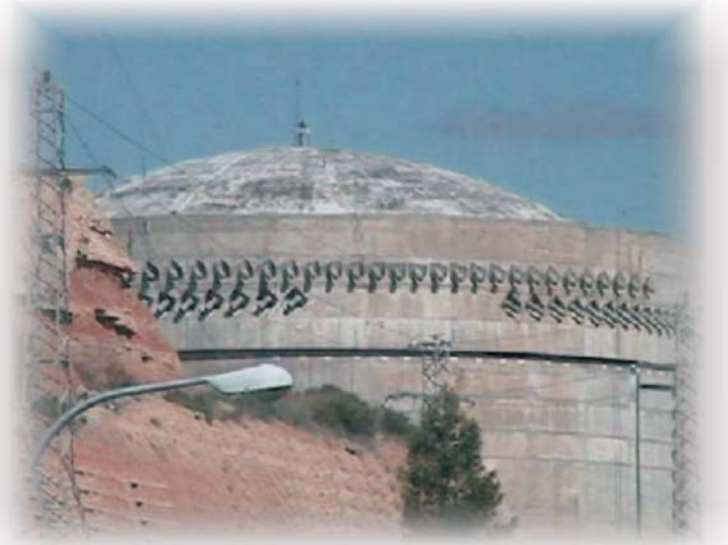
This massive concrete dome was showing signs of severe deterioration. The previously applied protective coating system had failed and hairline cracks were appearing throughout the dome structure. The plant

engineers needed a high performance coating material that would remain flexible, offer heat refractive properties and provide many years of weather protection to this critical structure.

The dome was thoroughly grit blasted by the ENECON Ibérica (Spain) Engineering Team and then

3 coats of ENESEAL HR were applied to completely encapsulate the dome, weatherproofing it and also providing a heat refractive shield to the concrete surfaces from the hot Mediterranean sun.

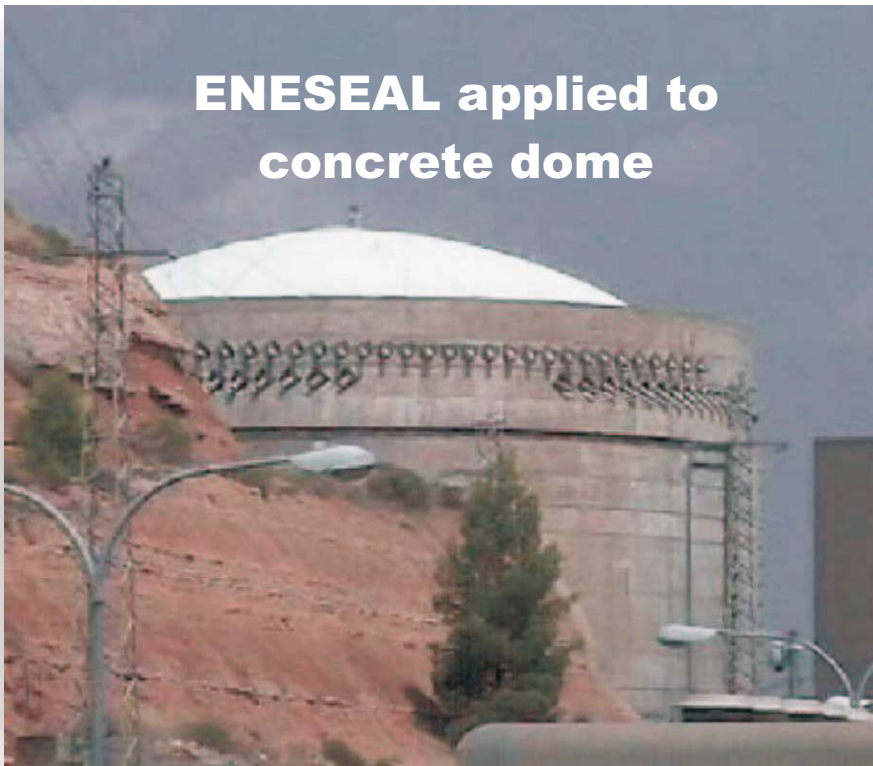
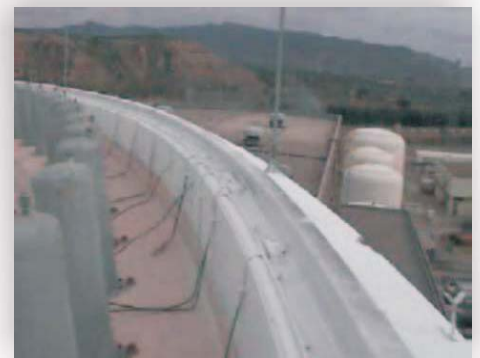
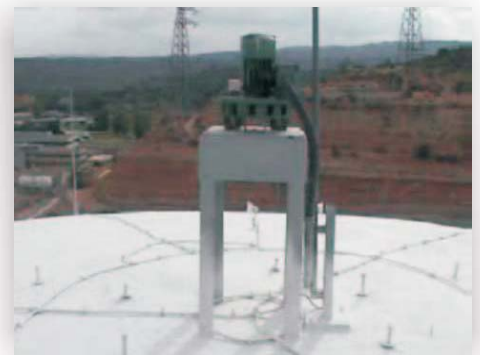
ENESEAL applied to concrete dome
