## Large Polish Warehouse Roof Sealed And Protected With ENESEAL HR

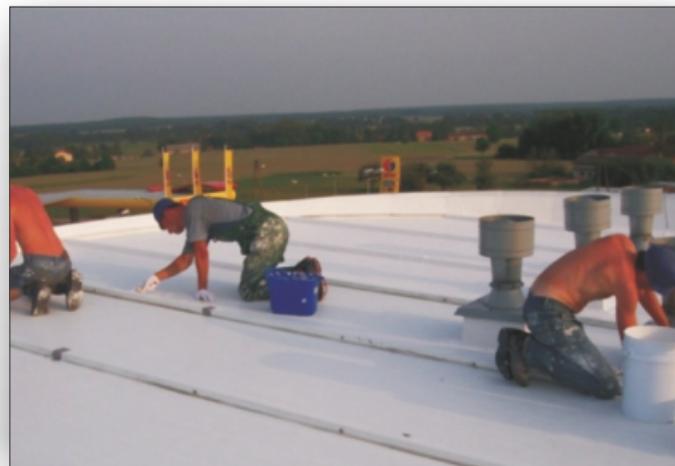
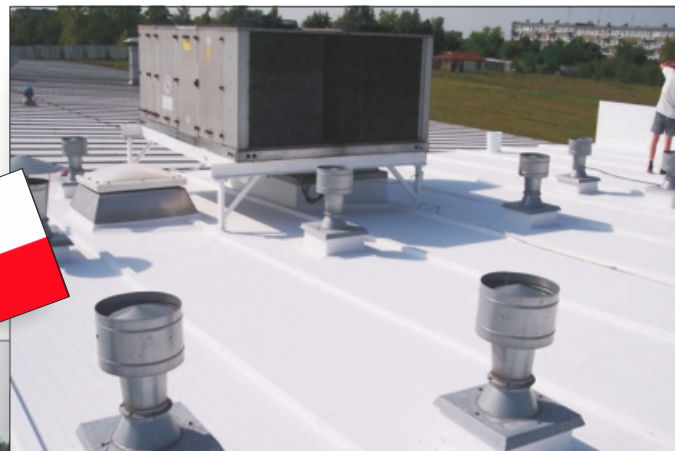
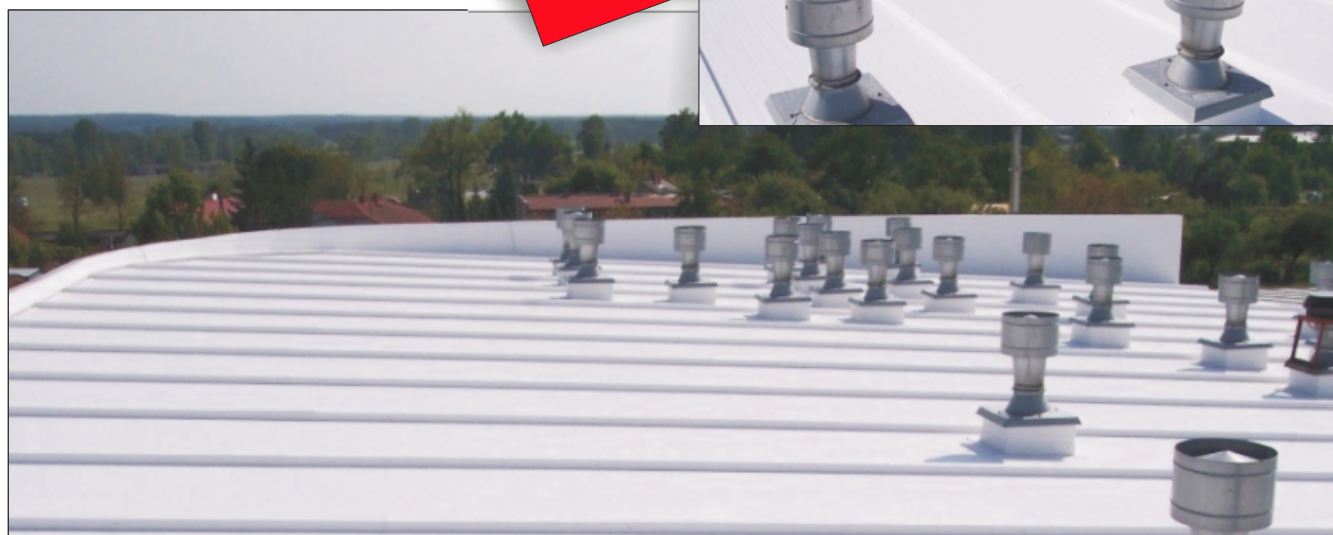
The plant engineers at this warehouse facility in Poland were looking for a high performance yet cost effective roof repair and protection system to seal the seams on this very large roof and then protect the roof from the elements.

cleaned the entire roof surface which included an alcohol rinse where needed. All joints and seams were first primed with ENECLAD SuperBond in order to insure the best bond possible in these critical areas. Two coats of ENESEAL HR were then applied over the entire roof area.
