## Largest Indoor Soccer Facility in North America Selects ENESEAL HR to Repair & Protect Roof

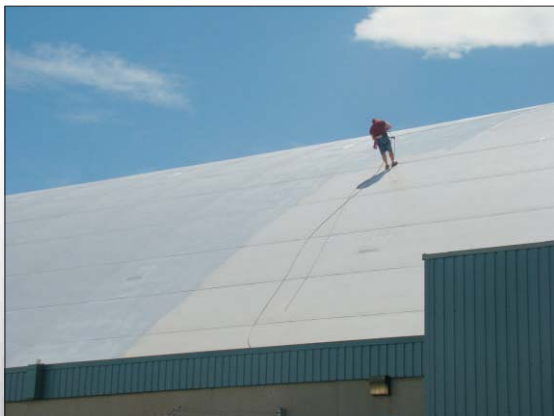
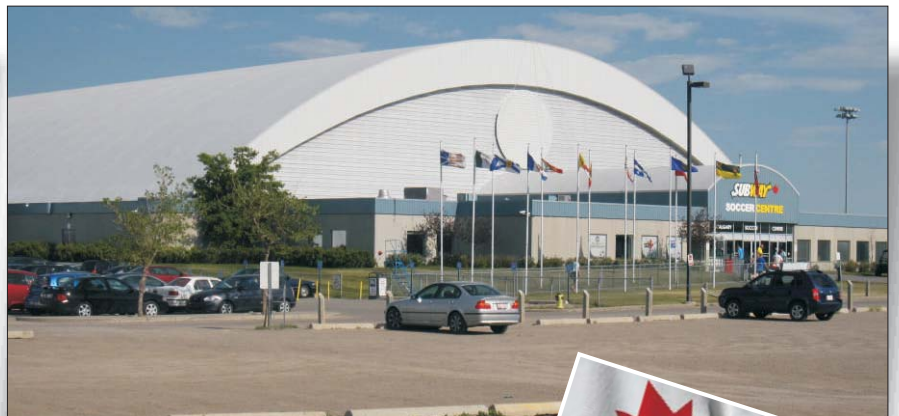
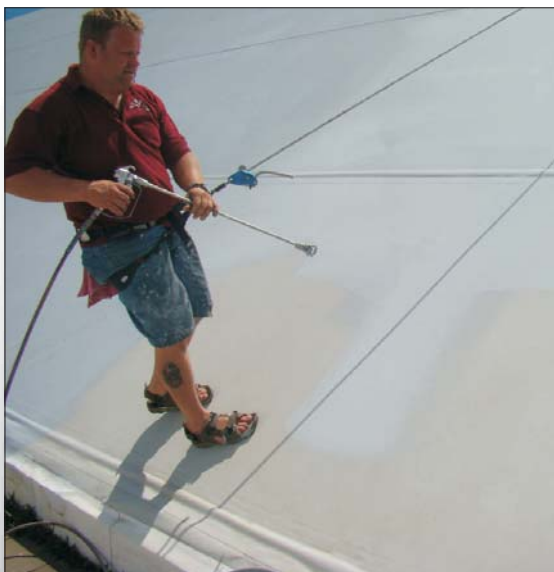
**Client:** Soccer Center  
**Location:** Alberta, Canada  
**Problem:** Leaking 20 year old roof.  
**Solution:** Repair over 300 holes and open seams in the roof with **SuperBond** + **ENESEAL HR** + reinforcement cloth. Spray-apply 2 coats of **ENESEAL HR** over entire roof area.  
**Cost:** \$400,000 turn-key project cost.  
**Savings:** Cost of conventional roof replacement was projected to be over \$2,000,000.
