Tennessee Hydroelectric Plant Uses ENESEAL CR to Protect Oil Tanks

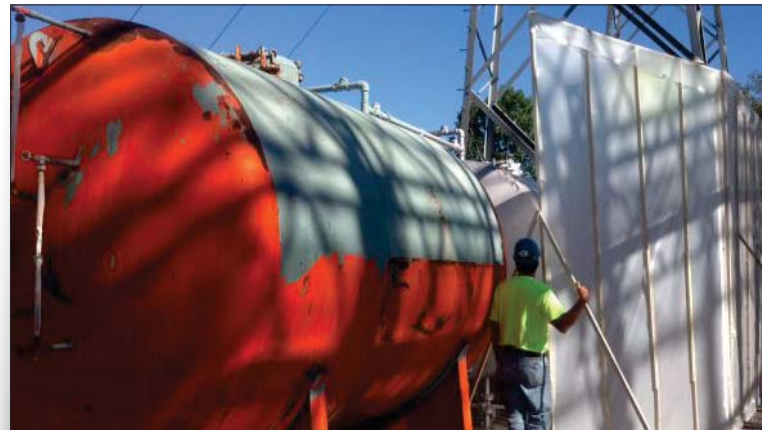
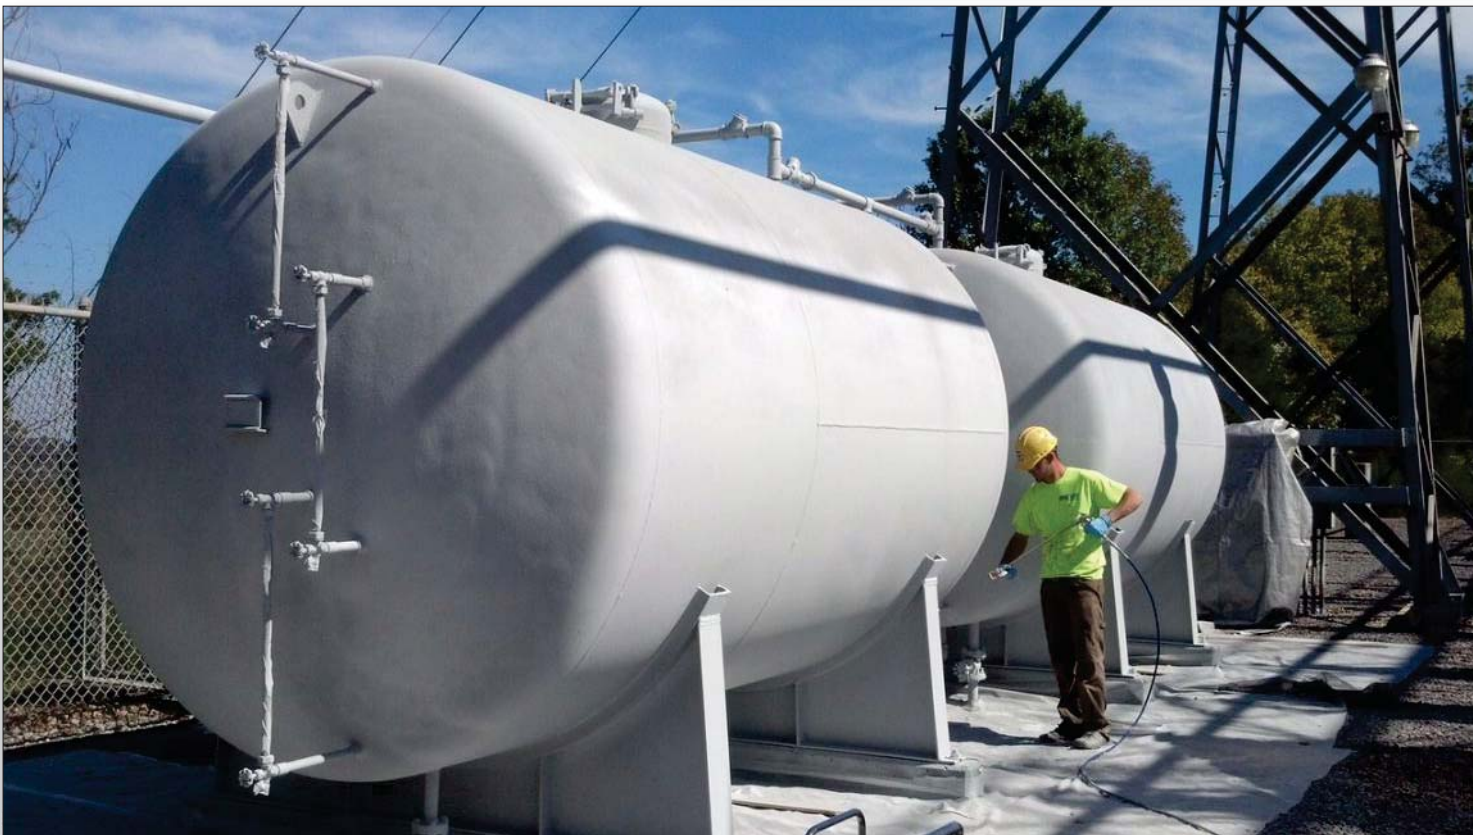
These large oil storage tanks located at a hydroelectric facility in Tennessee were in need of a new protective coating. The old lead-based paint was beginning to peel and surface corrosion was visible in certain areas.

Due to the safety risks associated with working with the surrounding high-voltage equipment, special temporary

containment was constructed prior to the tanks' surface preparation. The old lead-based paint was removed by pressure washing and then properly disposed of.

Two coats of ENESEAL CR were then applied providing a highly durable, corrosion resistant, elastomeric 'skin'.
