## ENESEAL CR Applied To Metal Storage Building Still Performs Since 2015

At a power sub-station in western PA, this metal storage building had severe corrosion issues. The substation engineers had to find a solution to protect the building as well as upgrade its appearance.

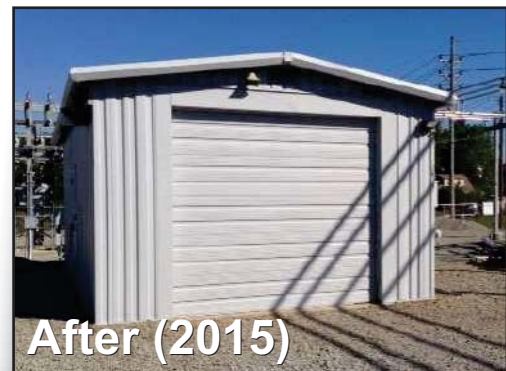
After (2015)

Two coats of ENESEAL CR, ENECON's corrosion resistant, flexible coating, were applied to the building, door and roof.

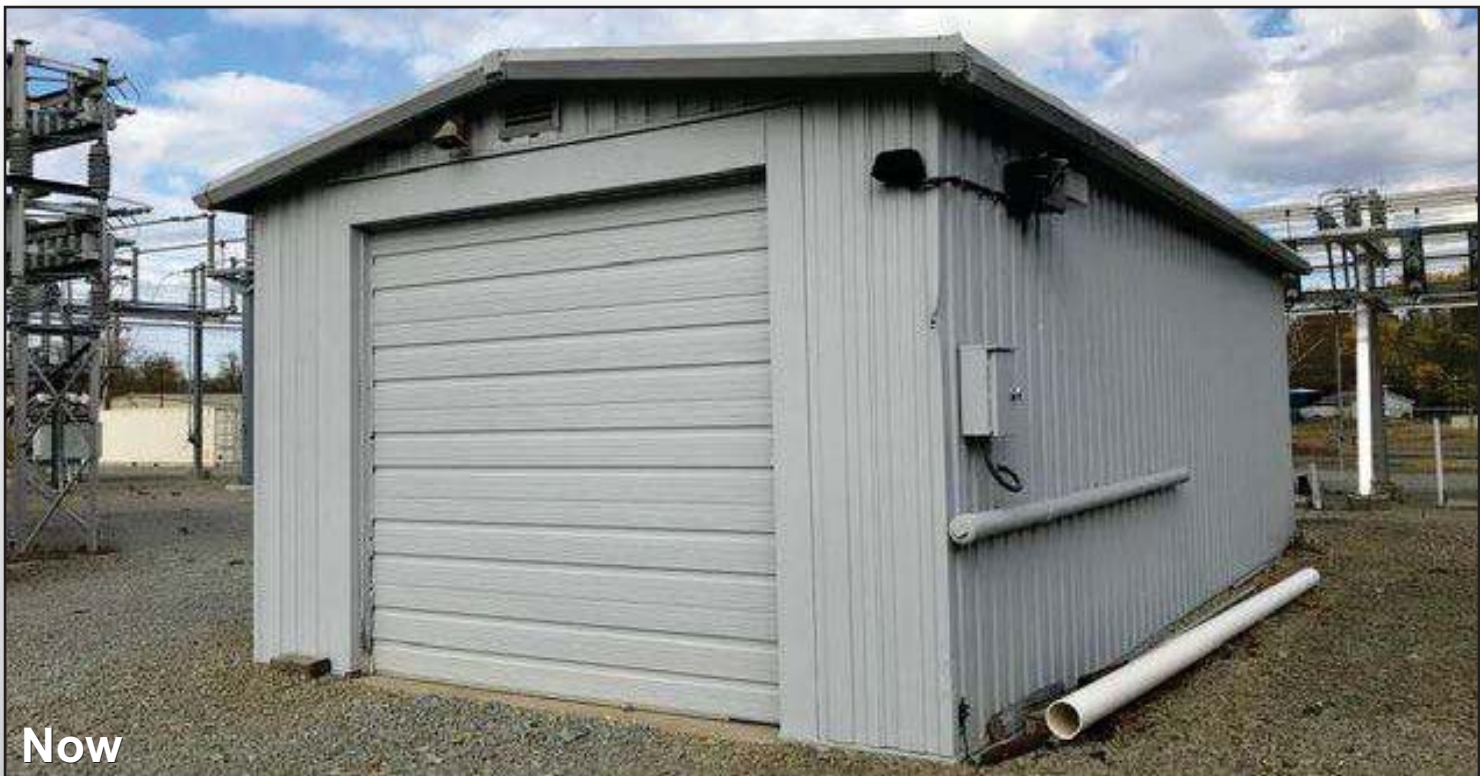
Now

Despite hot summer temperatures, and frigid PA winters, the shed was still in service and looks as good as it did the day it was originally protected.
