## \$300,000 Repair Project Completed at Major Northeastern Utility. 40-Year Old Cast Iron Water Boxes & Tube Sheets Repaired & Protected With CeramAlloy.

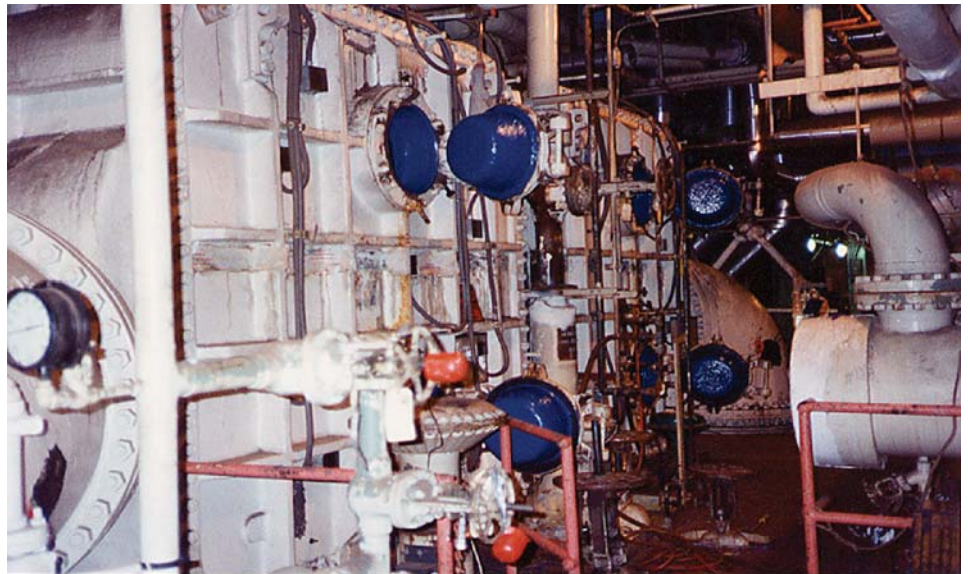
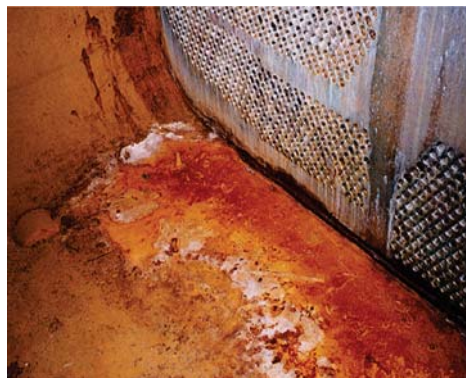
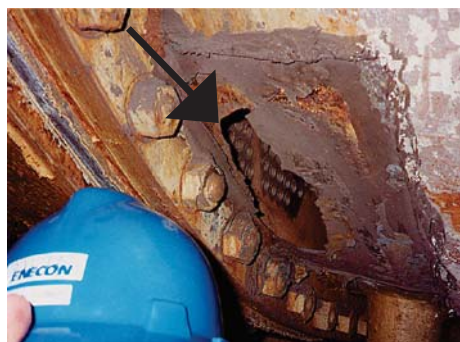
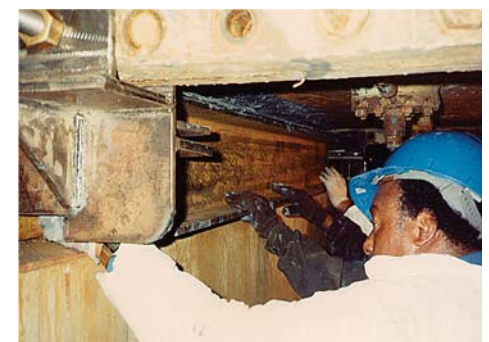
A total of 8 cast iron water boxes which were built in the 1950's plus 8 tube sheets were repaired, rebuilt and resurfaced with **ENECON CeramAlloy**

The cast iron water boxes were so severely damaged that huge holes, exposed during grit blasting, had to be repaired using steel plates and girders bonded and sealed with CeramAlloy.
