ENECON Italia Saves 90-Year Old Pump For The Italian Navy

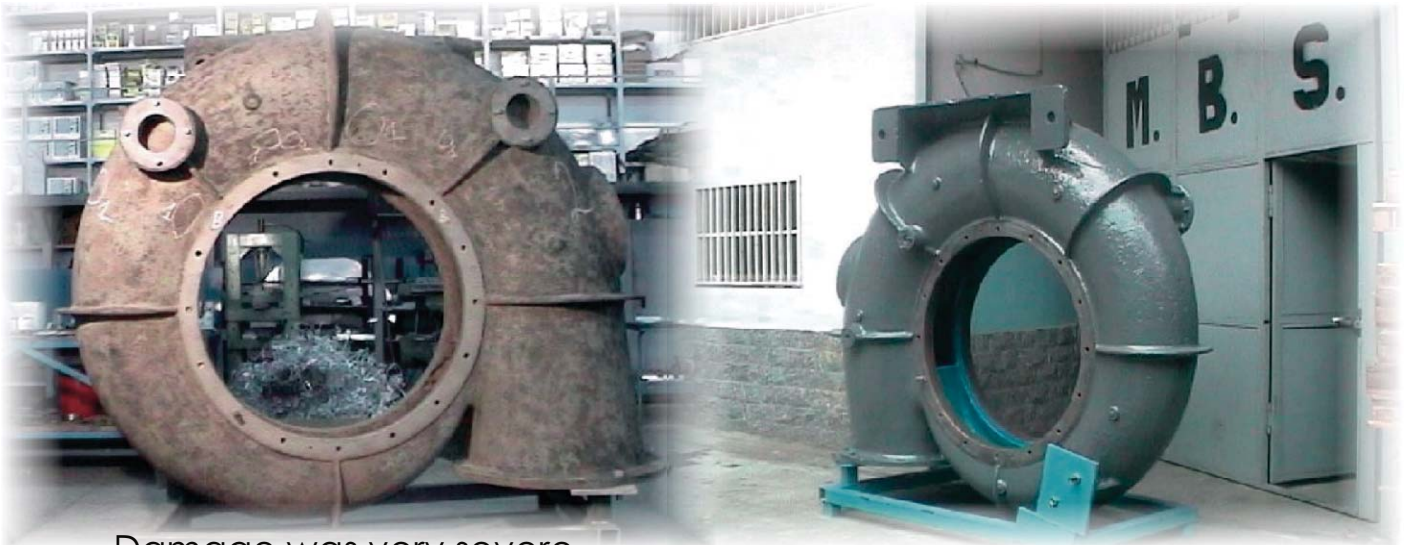
Damage was very severe

This huge, 90-year old, cast iron pump casing and impeller from an Italian Navy dry-dock were so severely eroded and corroded that the facilities engineers had decided to scrap it and order a new pump. The \$100,000 price tag for a new pump, however, persuaded the engineers to have the components rebuilt with ENECON High Performance Polymer Composite materials by the skilled engineering team at ENECON Italia.

The deeply pitted casing was first grit blasted then "primed" with CHEMCLAD SC. The

very deep pits were rebuilt with DuraQuartz and the entire surface coated with two coats of CeramAlloy CL+ [AC]. The outside of the casing was also protected with two coats of CHEMCLAD SC.

The damaged impeller was rebuilt with DurAlloy and then protected from future erosion and corrosion damage with two coats of CeramAlloy CL+ [AC].
