International Metals Manufacturer in Australia Solves Severe Wear & Abrasion Problems with CeramAlloy CBX

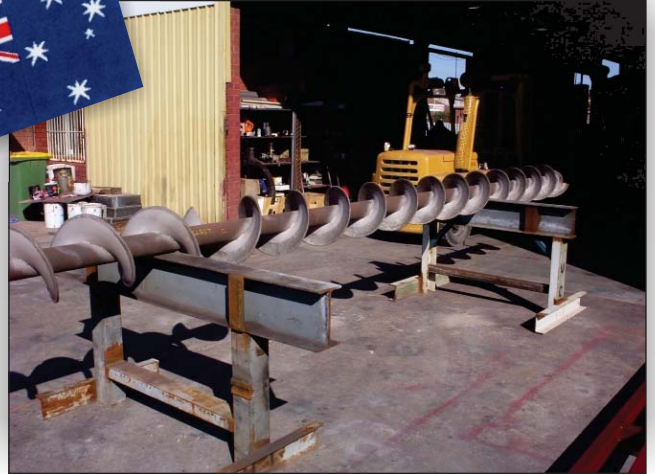
Conveyor after grit blasting

The ENECON Australia Engineering Team recommended **CeramAlloy CBX** to provide long-term protection to this critical piece of equipment. The screw conveyor was grit-blasted and then coated with 5 mm of CBX.

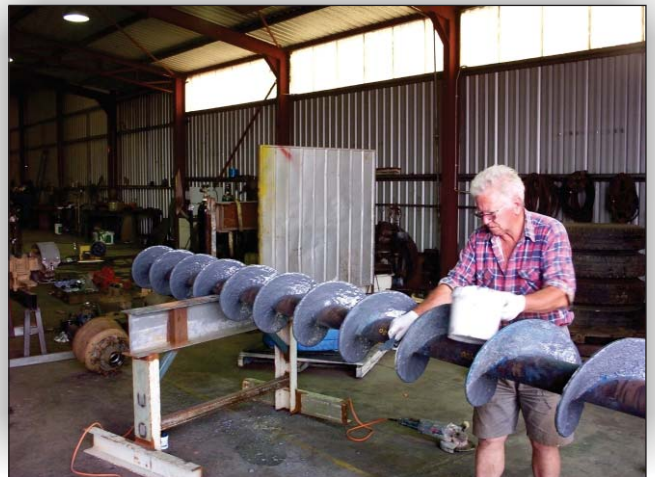
CeramAlloy CBX being applied

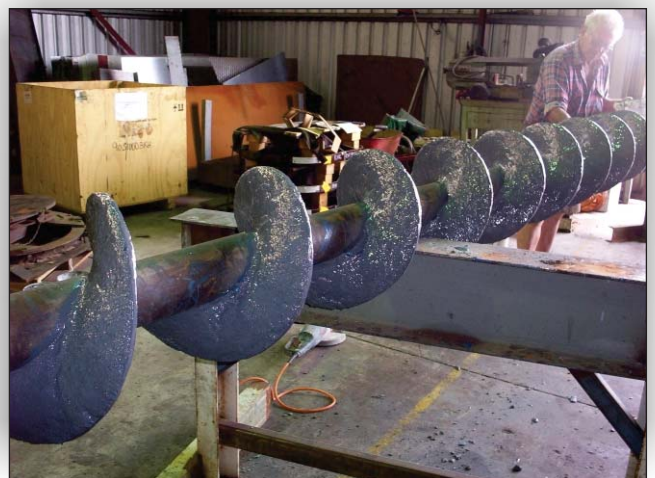
Screw conveyor protected with CBX
