Engineers at a Waste Water Treatment Plant Located in Philadelphia Repair Leaking Pipe Elbow with CeramAlloy

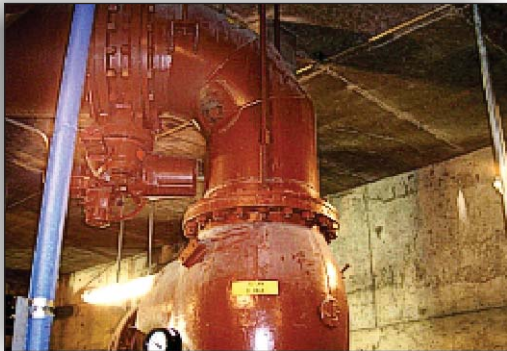
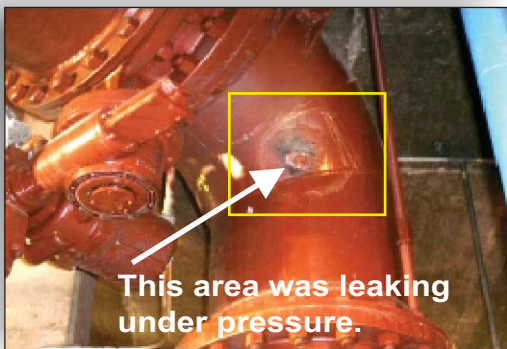
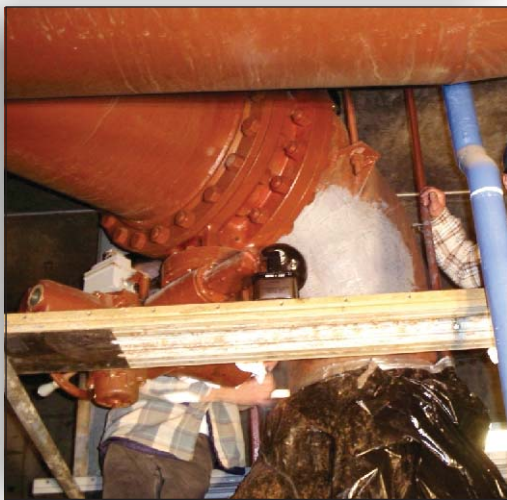
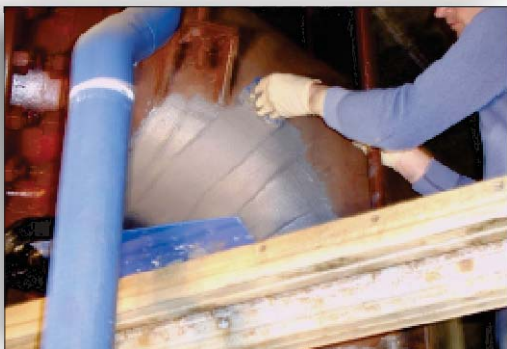
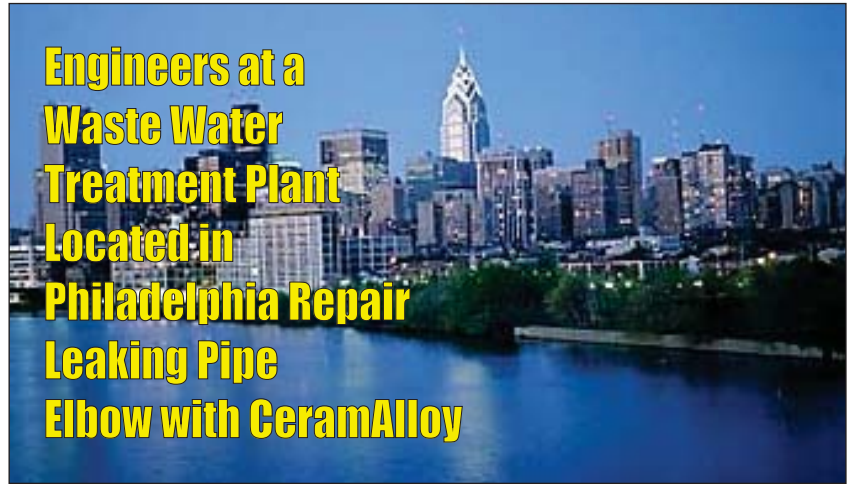
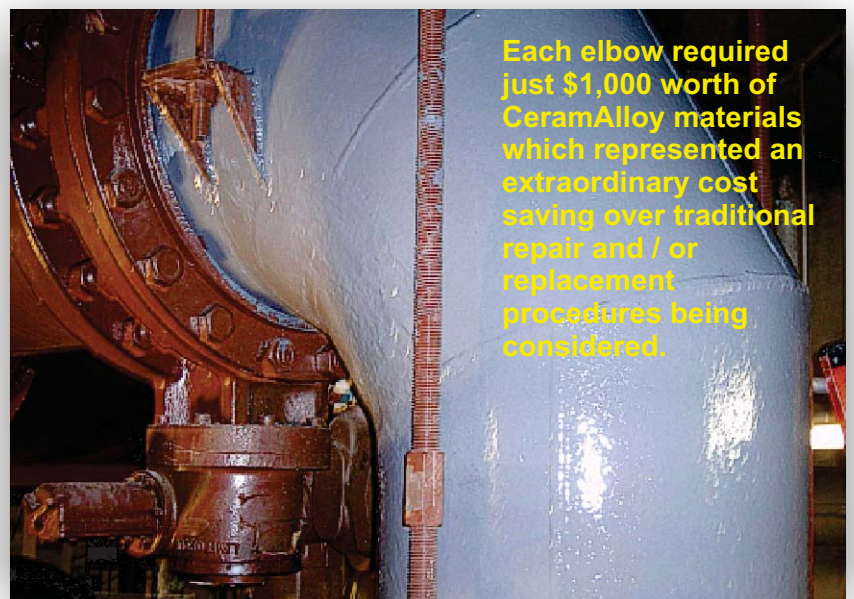
The maintenance engineers at this municipal waste water treatment facility needed a quick as well as cost effective repair on 8 RSP (Return Sludge Pump) exit elbows that had developed leaks. Removal and replacement was an expensive and time-consuming option that would have left the plant vulnerable

to systems overload and possible shut-down.

ENECON engineers suggested an unconventional solution: repair and rebuild the elbows with CeramAlloy CP + AC and CL + AC.

An added cost saving consideration was that all the work could be done by

the plant's own maintenance engineering staff with in-field technical support provided by ENECON's Engineering Team.

Each elbow required just \$1,000 worth of CeramAlloy materials which represented an extraordinary cost saving over traditional repair and / or replacement procedures being considered.
