Military Sealift Command Vessel's Rudder Shafts Repaired & Protected With DurAlloy & CeramAlloy

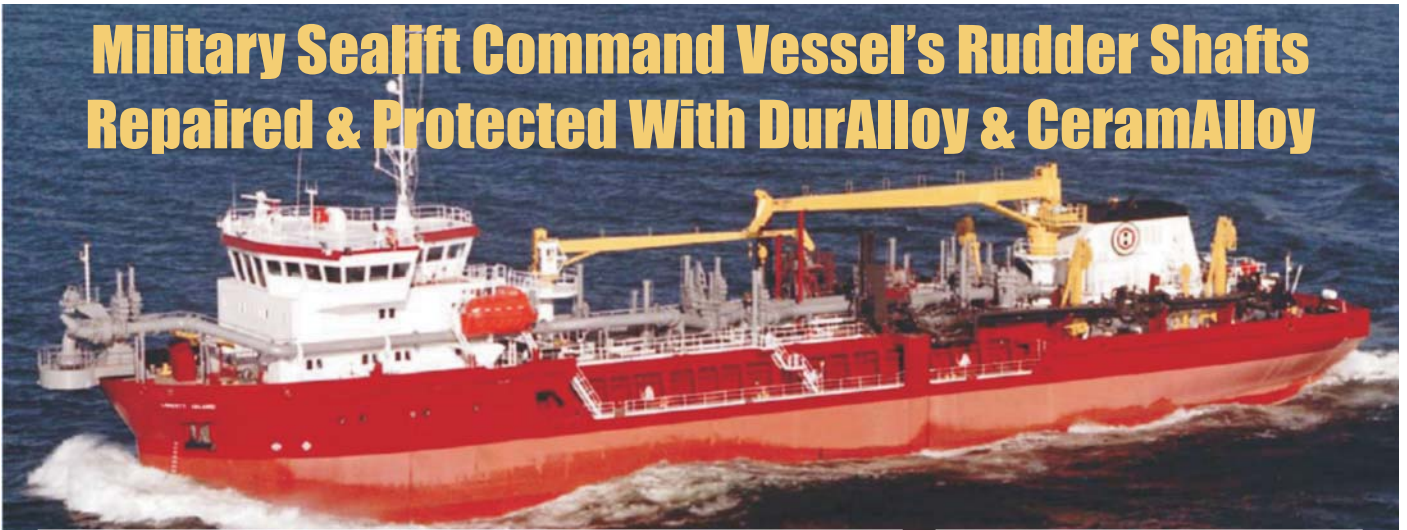
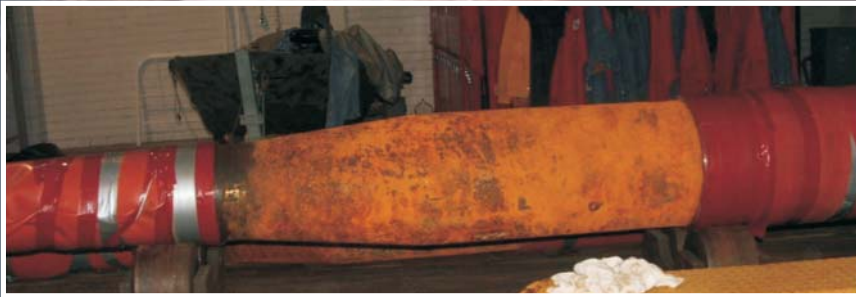
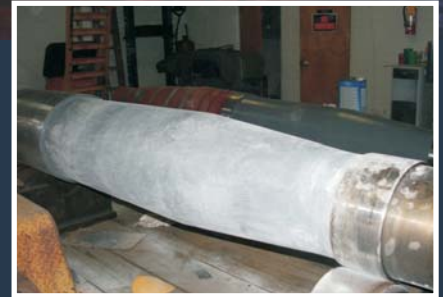
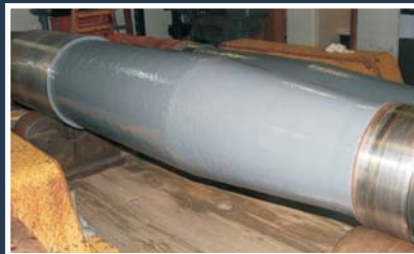
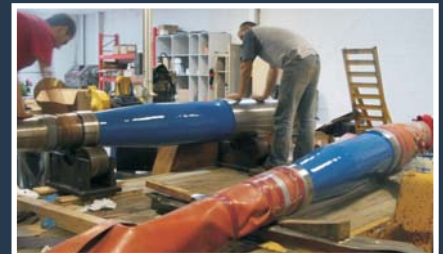
The Military Sealift Command (MSC) needed to effect a cost effective repair on these two rudder shafts from a dredger. They contacted their local ENECON Engineering Team based in South Carolina who recommended using DurAlloy to rebuild the tapered shafts back to original specifications followed by the application of CeramAlloy CL+AC to provide a smooth, wear-resistant surface.

These pictures illustrate the repair procedure as well as the extraordinary final result.
