New York City Office Building Saves 16 Inch Refrigeration Pipe with METALCLAD DuraWrap

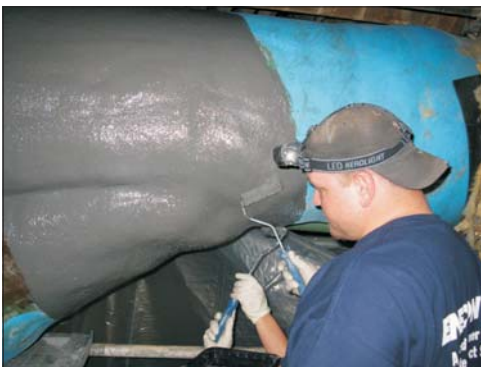
After identifying the exact location of the leak, the area was prepared by abrading the surface. **DurAlloy** and multiple layers of

reinforcement cloth were then used to make the repair.

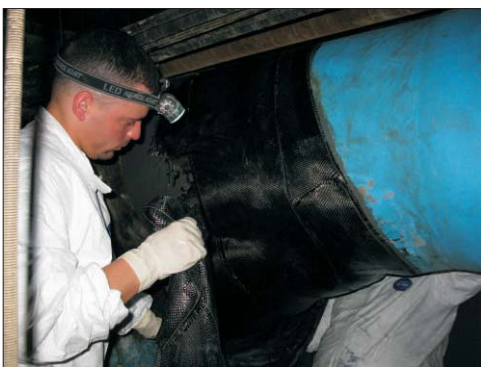
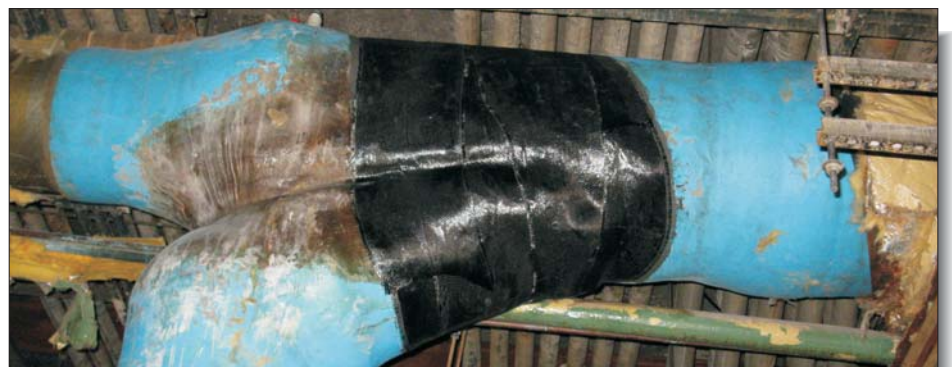
The pipe was then primed using the **DuraWrapPrimer**. The carbon fiber fabric was thoroughly 'wetted-out' with the **DuraWrap Polymer** and then applied to the pipe.
