Tugboat Operator Selects CeramAlloy to Combat Erosion/Corrosion on Their Kort Nozzles

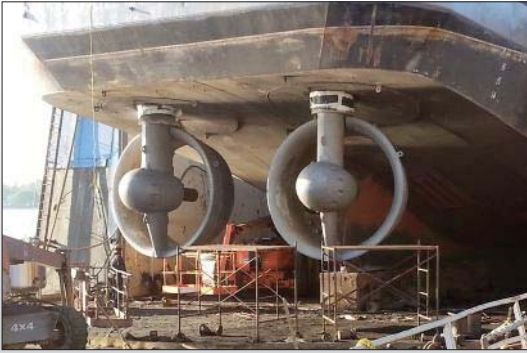
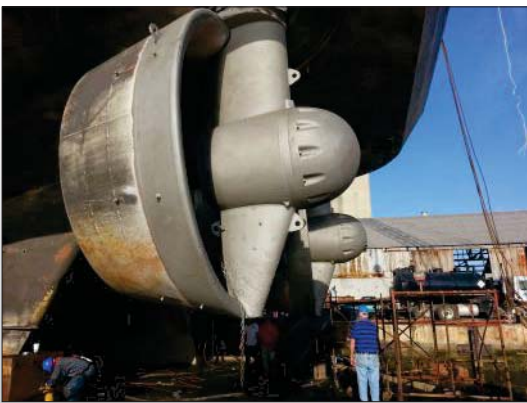
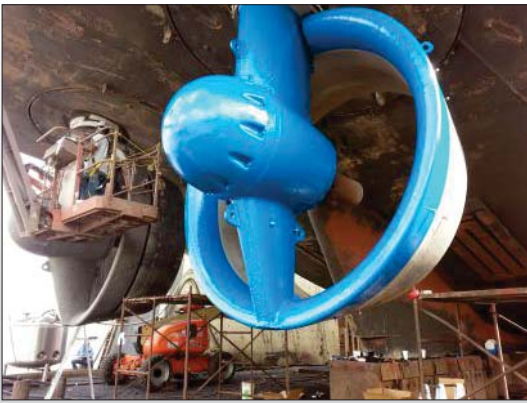
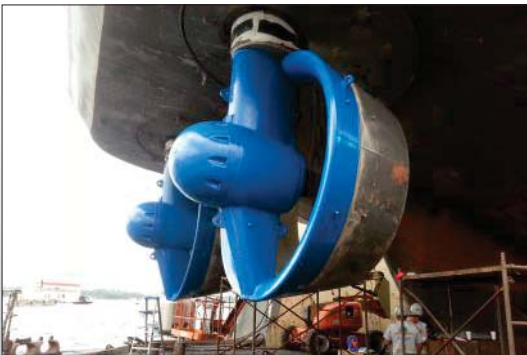
This tugboat belonging to a major international marine company in Florida was suffering from the effects of erosion & corrosion on its Kort nozzles. The local ENECON Fluid Flow Systems Specialist was called in to help find a solution.

After preparing the surface by grit blasting to acquire a 'white metal' finish, two coats of CeramAlloy CL+AC were applied.

The owner of the vessel was so pleased with the final results that another tugboat's Kort nozzles have already been scheduled for repair.
