DuraWrap Repairs Power Plant Cooling Tower Supply Line

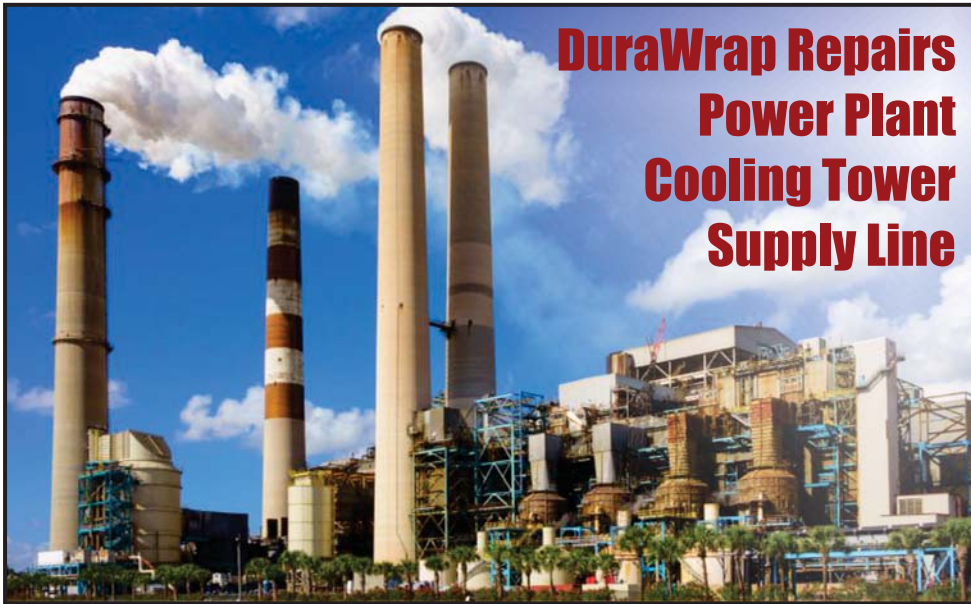
This 24 inch diameter intake pipe, located at a U.S. Power Plant, was leaking above the ground just below the disc valve. The plant's maintenance engineers needed a proven, reliable and economical solution to this problem.
