The coupling joints of these 48 inch diameter pipes were leaking. The pipes carry wastewater to clarifier tanks at the 5th largest wastewater treatment plant in the U.S. There are 12 of these pipes and they each have 3 couplings (36 total).

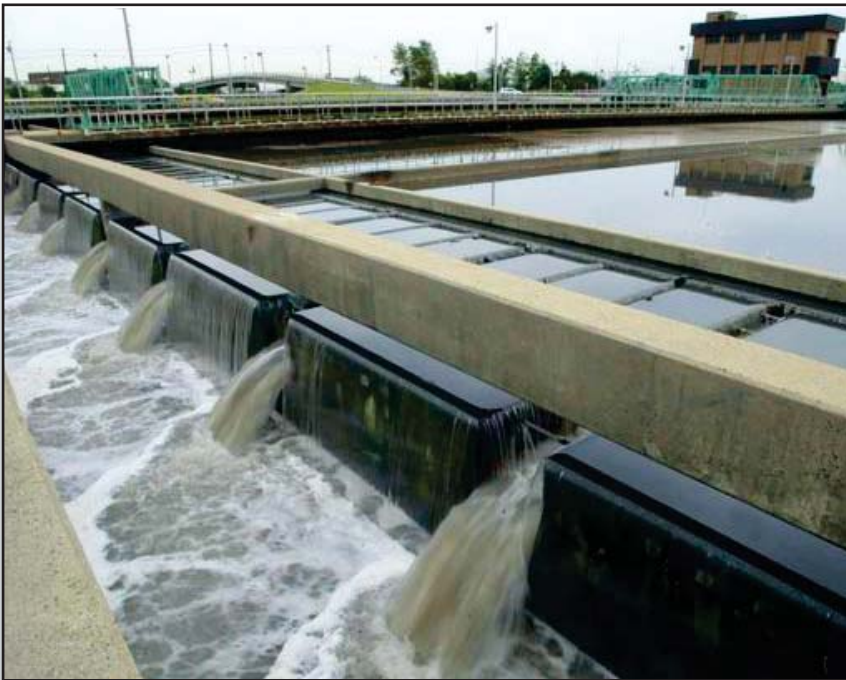
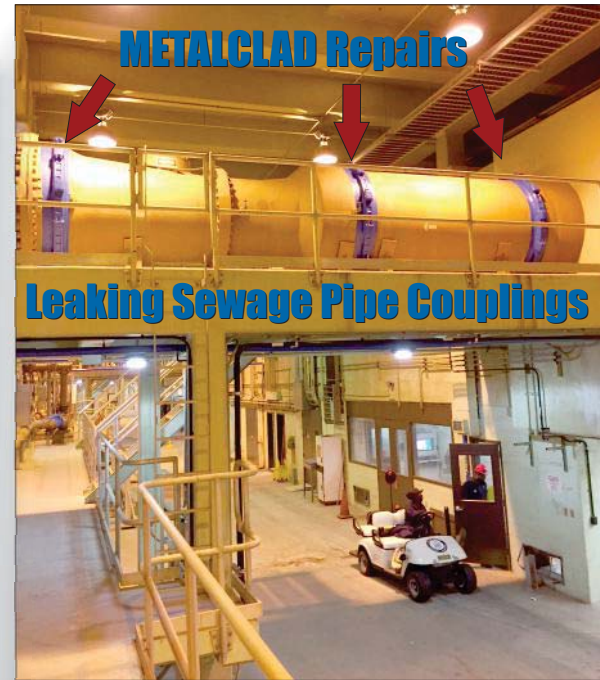
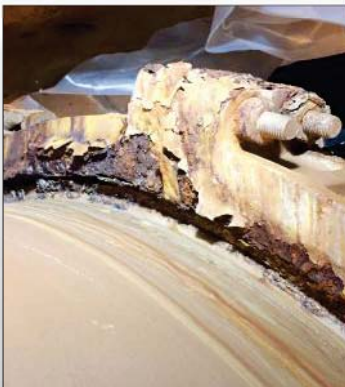
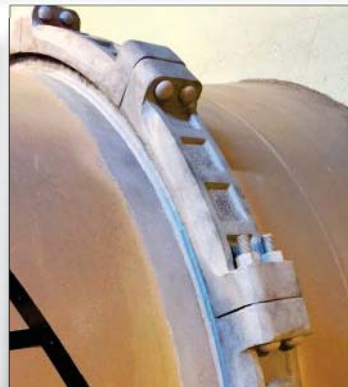
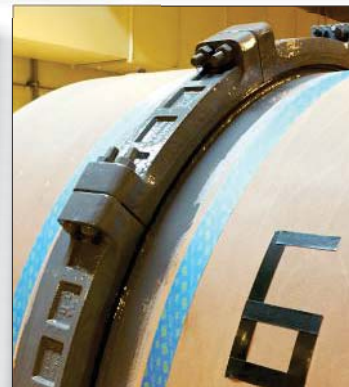
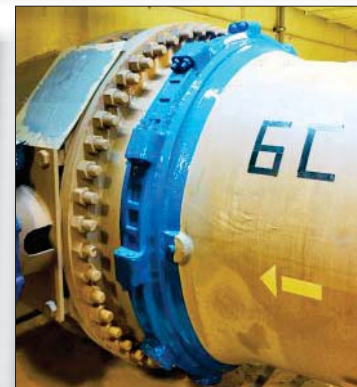
Numerous, unsuccessful, attempts to fix the leaks

on these critical pipes had been made. Since the system could not be shut down to replace these couplings, the local ENECON Field Engineering Specialist was contacted to find a solution.

After a thorough examination, it was recommended that the couplings be grit blasted

and SpeedAlloy QS be used to stop the active leaks. Once the leaks were stopped, CeramAlloy CL+AC (Gray) was used to wet out each side of the coupling and DurAlloy was applied to make any repairs.

A second coat of CeramAlloy CL+AC was applied to the entire

coupling area, followed by a final top-coat of CeramAlloy CL+AC (Blue) to completely seal and encase the couplings.
