Louisiana Pump Repair Shop Uses CeramAlloy To Repair, Not Replace Pump Impeller Destined For The 'Bone Yard'.

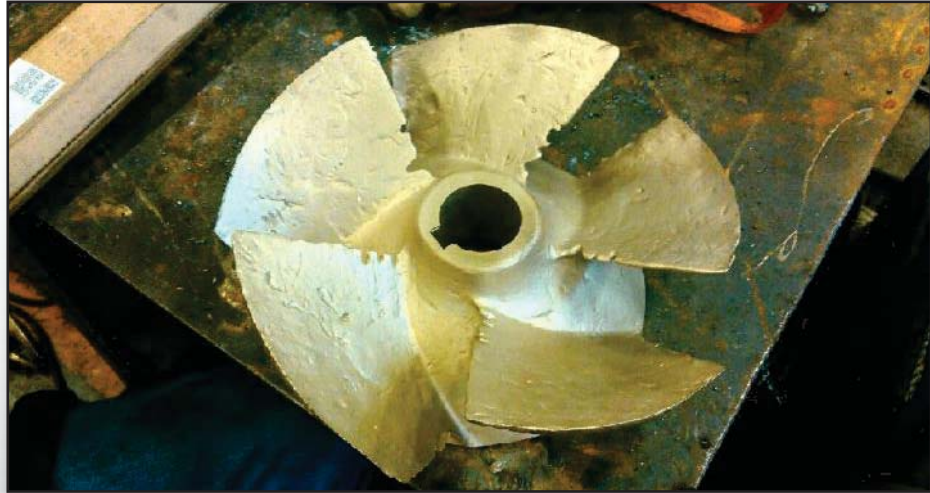
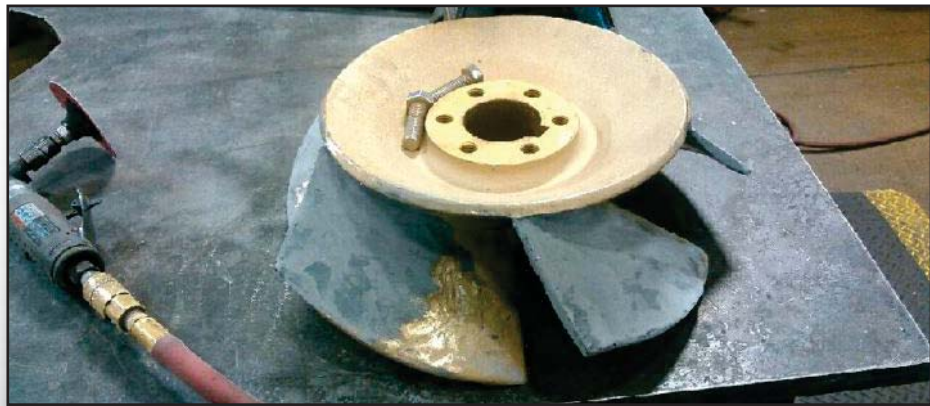
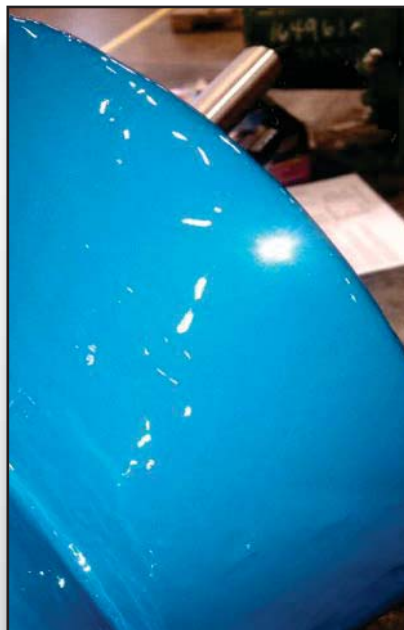
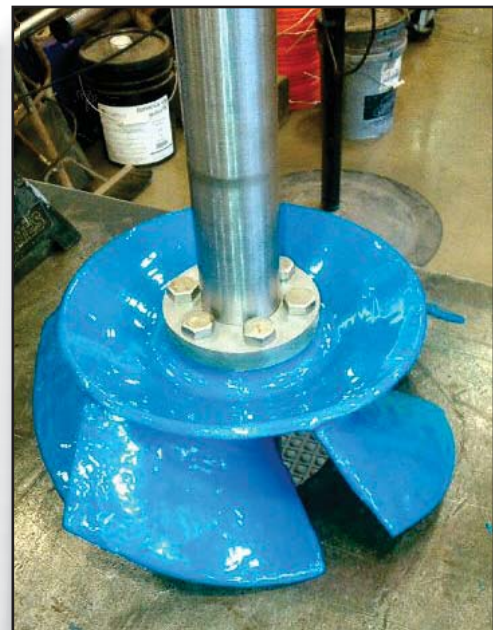
This pump impeller from a Louisiana water treatment plant was headed to the scrap heap. Normally, an impeller in such bad condition would be replaced. The pump repair shop decided to contact their local ENECON Field Engineering Specialist to find an alternative solution.

The impeller was first grit blasted down to a white metal finish. The damaged veins were rebuilt with CeramAlloy CP+AC. The entire impeller surface was then given two coats of CeramAlloy CL+AC.

Repairing this impeller instead of replacing it saved the customer over \$6,000. The entire project was completed in just three days. A replacement would require an eight week lead time. This is a classic example of the benefits associated with repair vs. replacement.
