The Largest WWTP In Europe Repairs & Reinforces Its Main Outfall Pipe With METALCLAD DurAlloy & DuraWrap

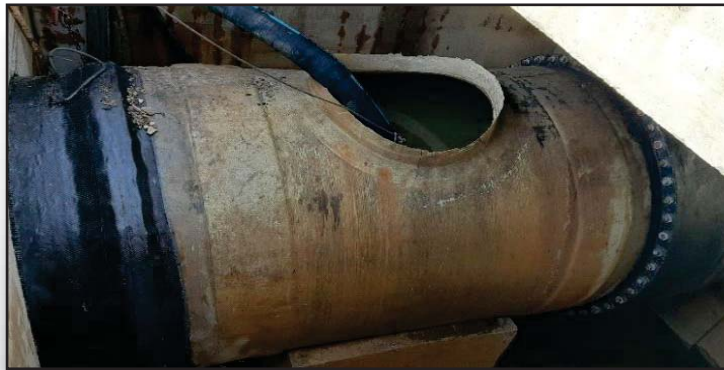
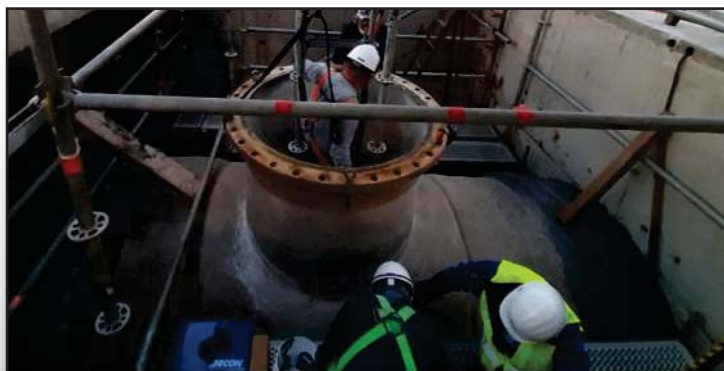
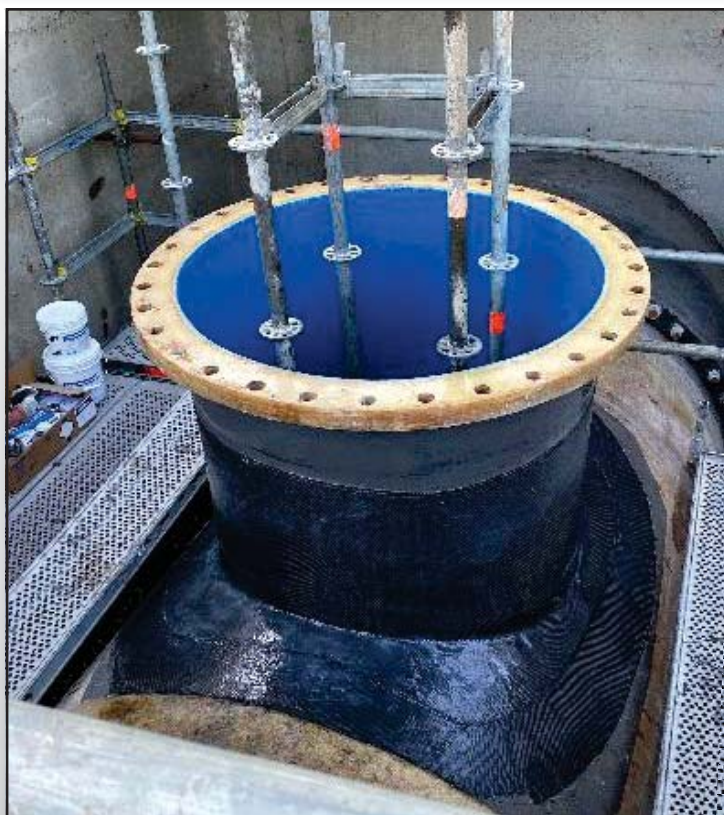
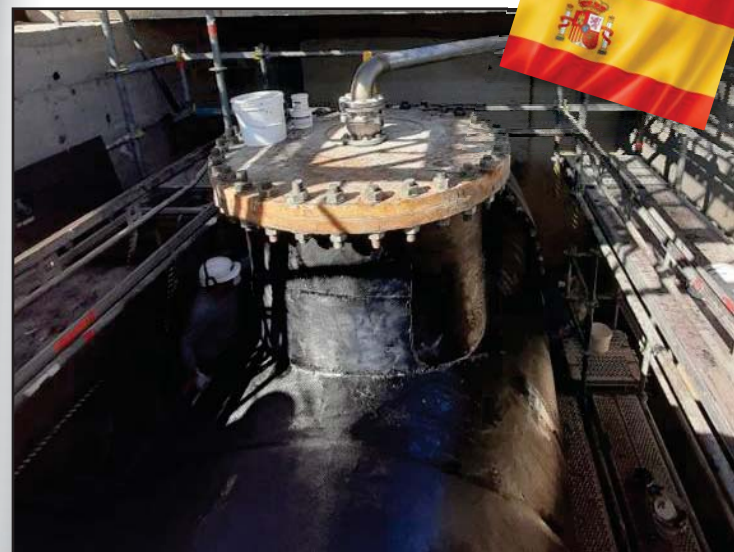
After the successful structural reinforcement of the two ends of the outfall of a wastewater treatment plant (WWTP) in Spain, which had lost much of its thickness due to corrosion in a steel section as well as cracks in the GRP section (glass fiber reinforced plastic), the WWTP called the ENECON distributor in Spain (PROENECON) because of an unexpected break of the pipe's neck. This was the 47 inch diameter GRP junction with the main 83 inch GRP pipe.

This repair was much more complicated than the previous one since, in this case, it was a total break causing a flood. The water

level could not be lowered more than $\frac{3}{4}$ of an inch below the area of the break. After divers retrieved the junction from the bottom of the water-filled manhole, the PROENECON technicians proceeded to glue it to the main pipe using METALCLAD DurAlloy. Then they reinforced the joint both on the inside as well as the outside with DuraWrap.

The DuraWrap provides structural reinforcement for pressure pipes, meeting ASME PCC2 and ISO TS 24827 certification permitting the outfall to be commissioned in just one week.
